## Summary of disputed items

Item 1.

Amtico flooring laid uneven.

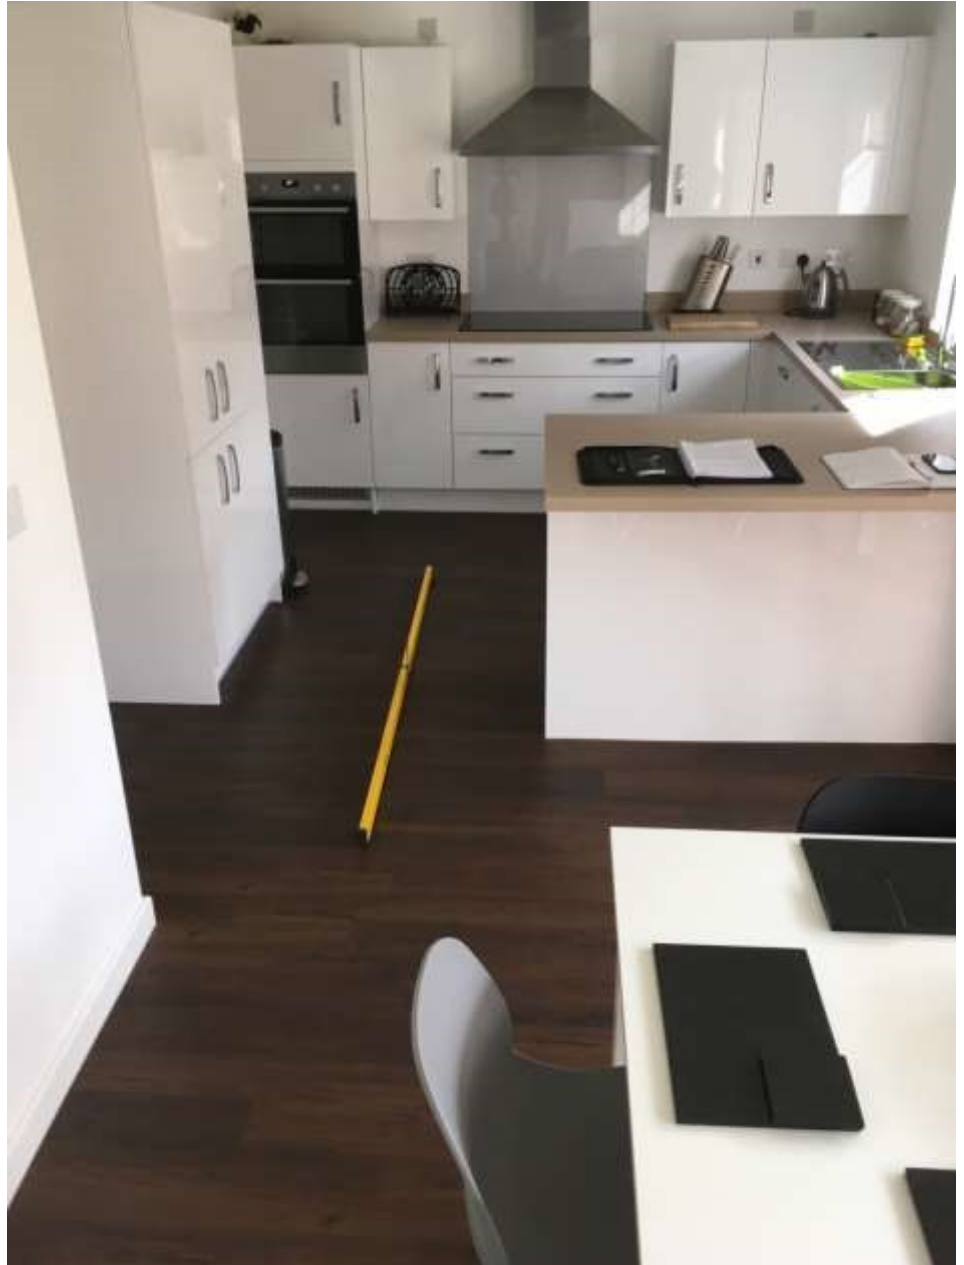
*Amtico floor finish to kitchen. Excessive dip in floor to area below spirit level.*

I recommend that the builder undertakes work to rectify the highlighted excessive dip in the floor between the kitchen base unit and the tall fridge freezer unit, and also to the cloakroom floor. Re-levelling work should bring the floor to within NHBC tolerances of +/- 5mm, and may require the temporary removal of some kitchen units and cloakroom sanitary ware along with areas of the Amtico floor covering.

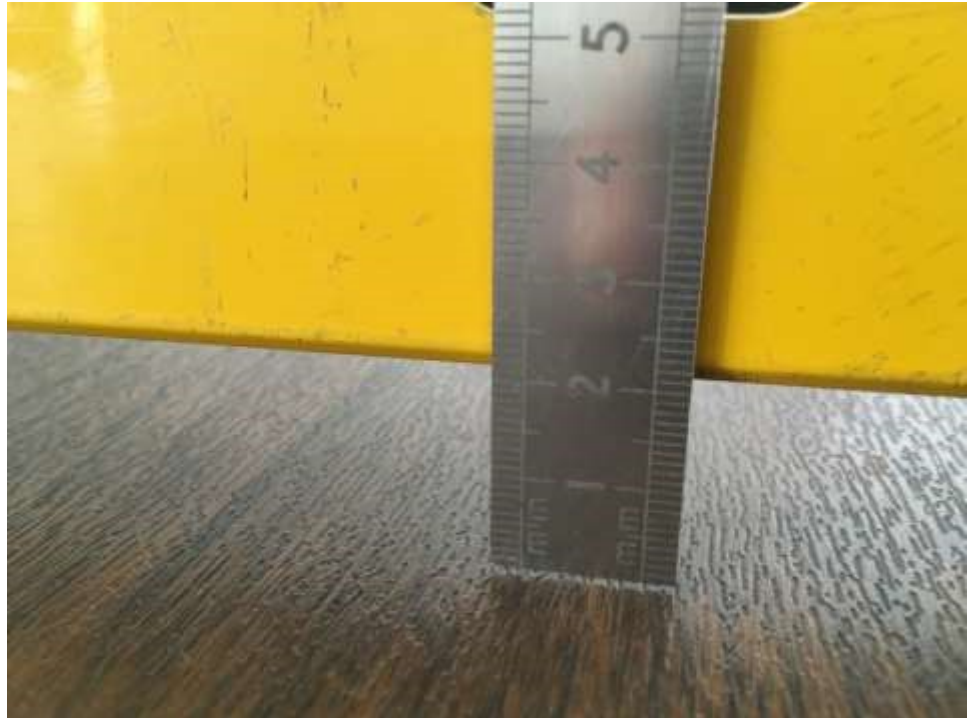
*Dip measured at 20mm. 10mm offsets used below ends of 2m straight edge.  
NHBC tolerance is +/- 5mm using a 2 metre straight edge with equal offsets.  
Dip therefore 5mm over allowable tolerance and considered excessive.*

Unevenness of floors are covered under NHBC Standards Chapter 9.1.5, which states that floors should be flat within a +/- 5mm deviation, measured using a 2 metre straight edge with equal offsets.

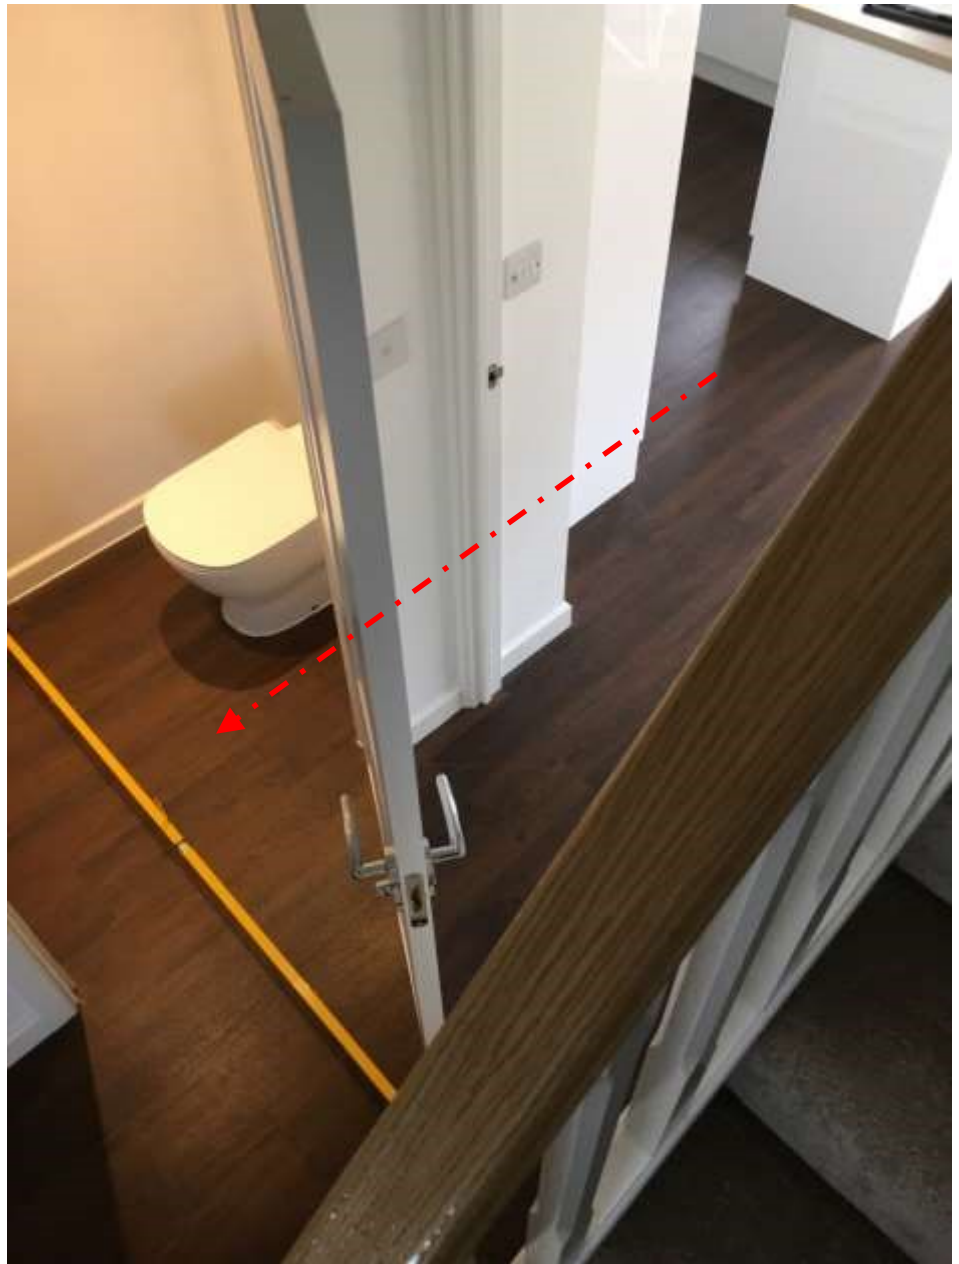
*Excessive dip in floor runs through into cloakroom.*

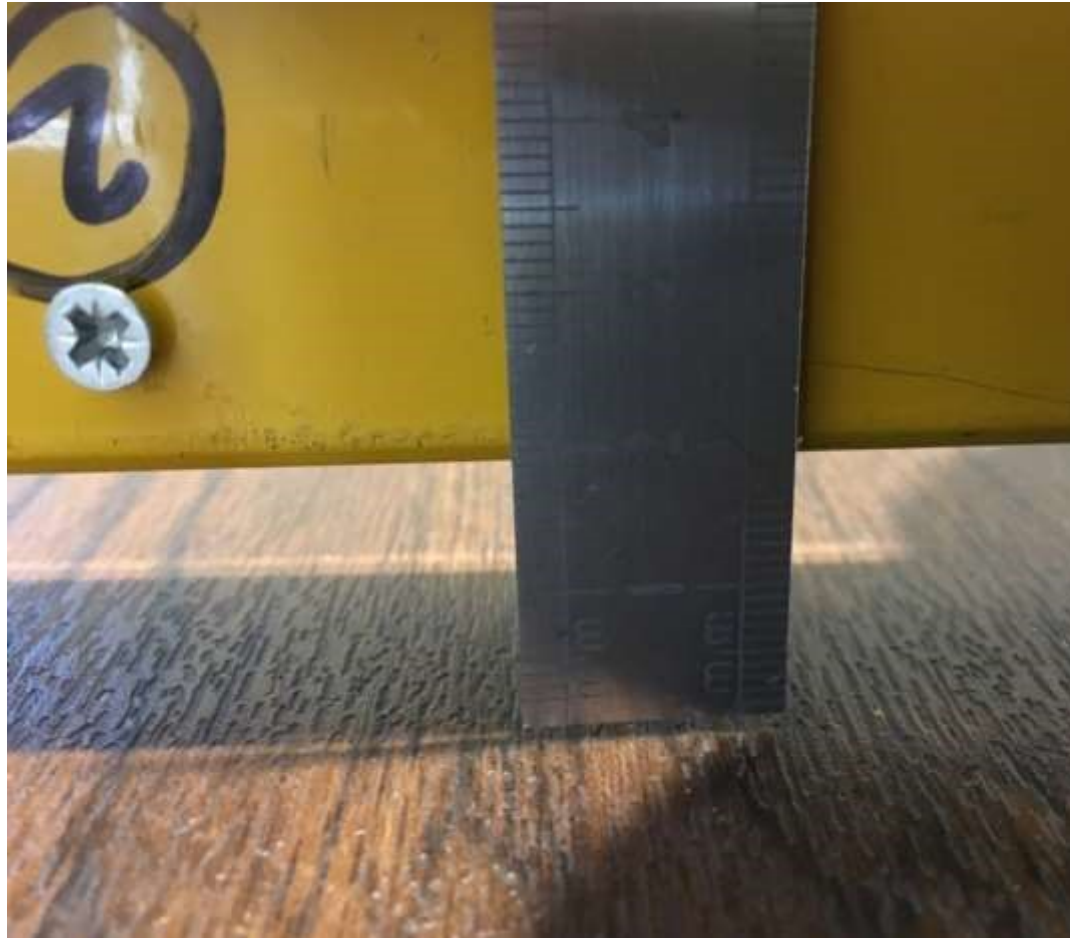
*Dip measured at 19mm. 10mm offsets used below ends of 2m straight edge. NHBC tolerance is +/- 5mm using a 2 metre straight edge with equal offsets. Dip therefore 4mm over allowable tolerance and considered excessive.*

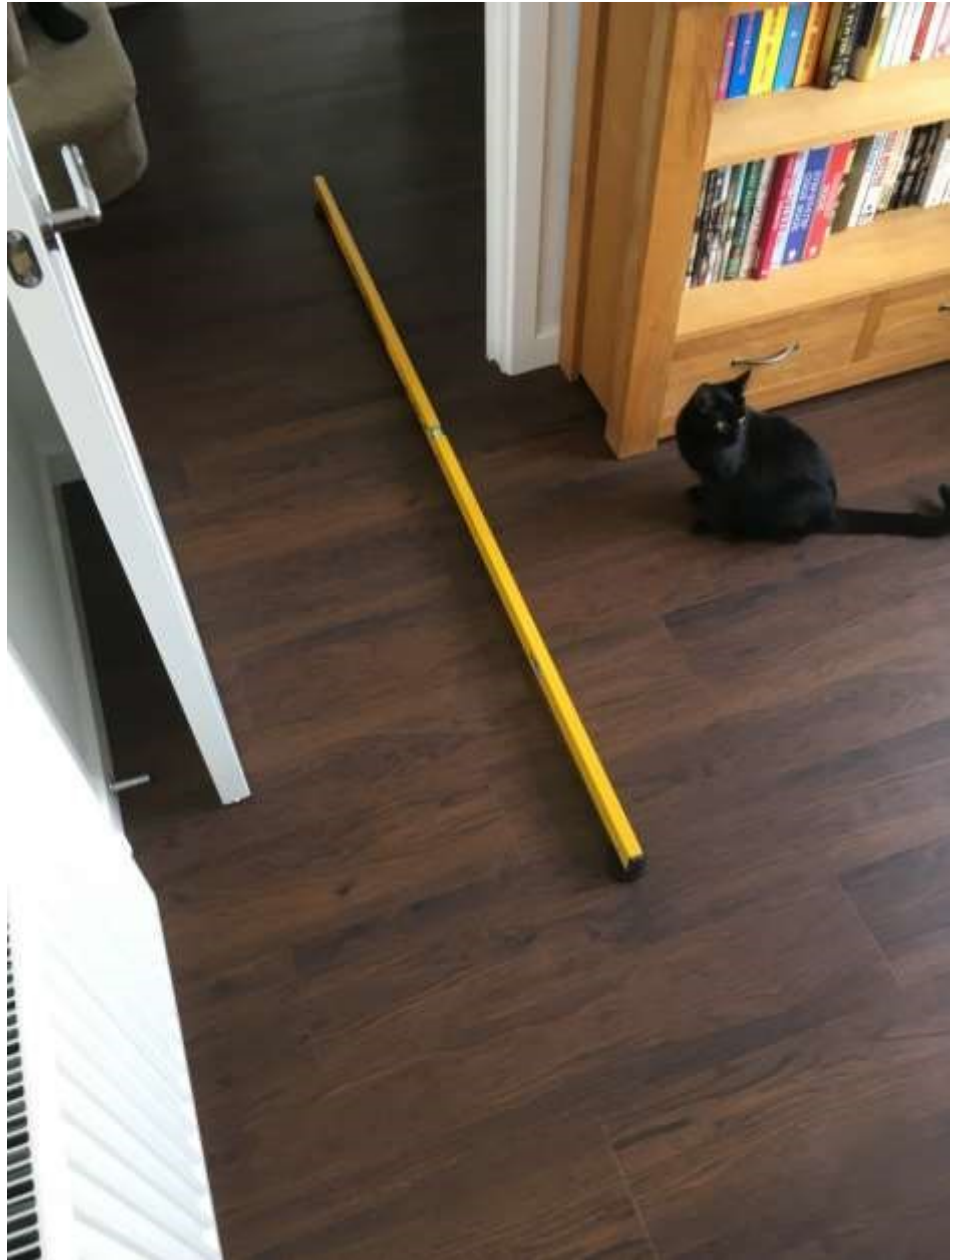
*Floor measured across hall to study to check dip in floor. Cloakroom is to the left behind the study door.*

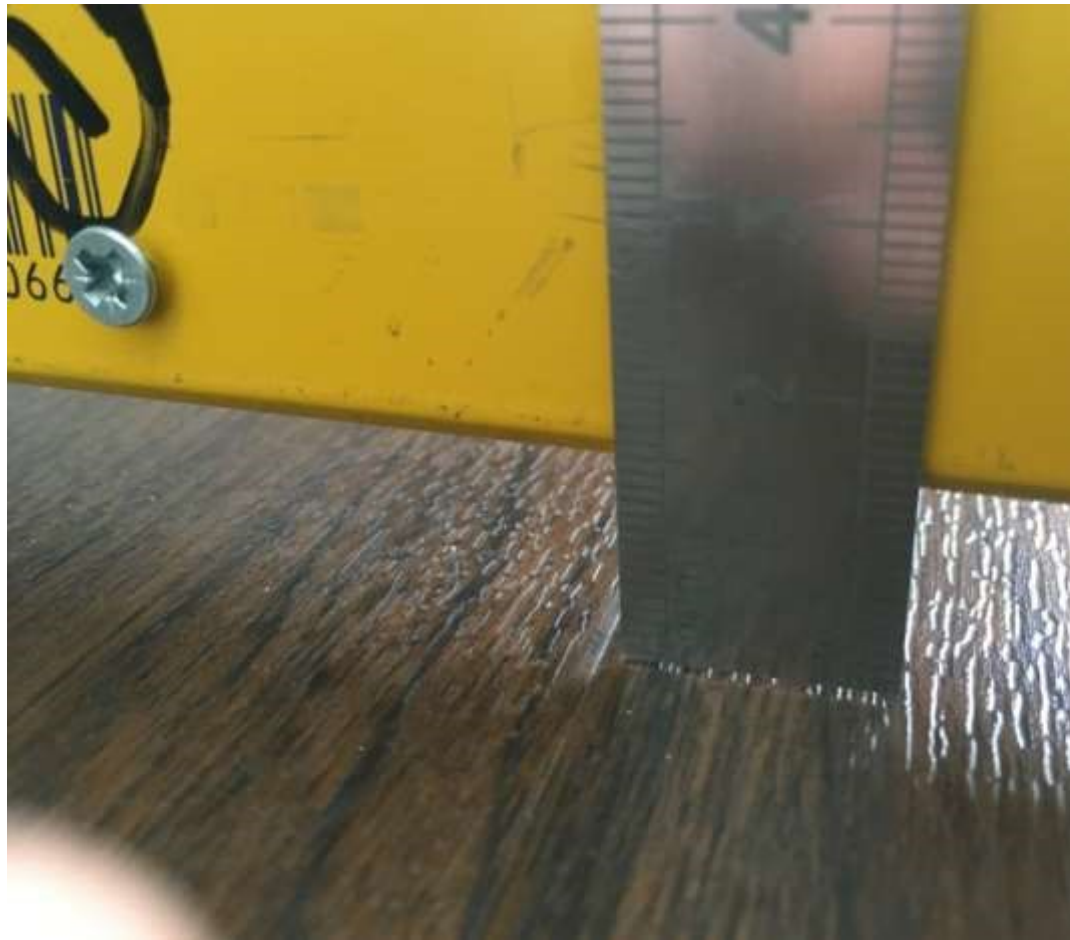
*Dip measured at 14mm. 10mm offsets used below ends of 2m straight edge. NHBC tolerance is +/- 5mm using a 2 metre straight edge with equal offsets. Dip therefore 1mm within allowable tolerance and considered acceptable.*

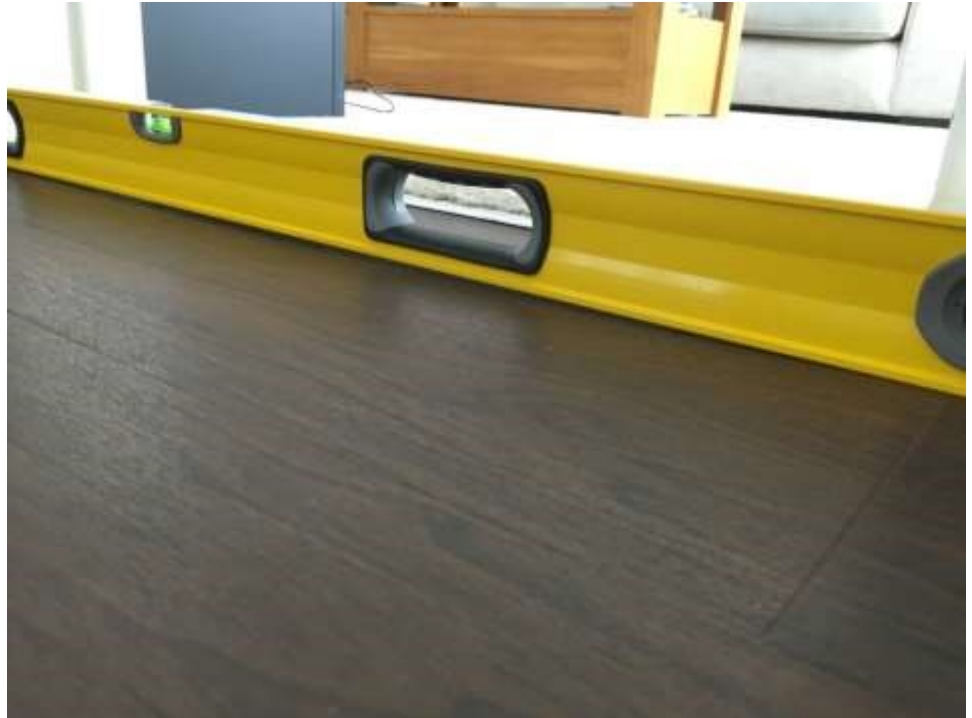
*Floor reasonably flat between hall and lounge door threshold.*

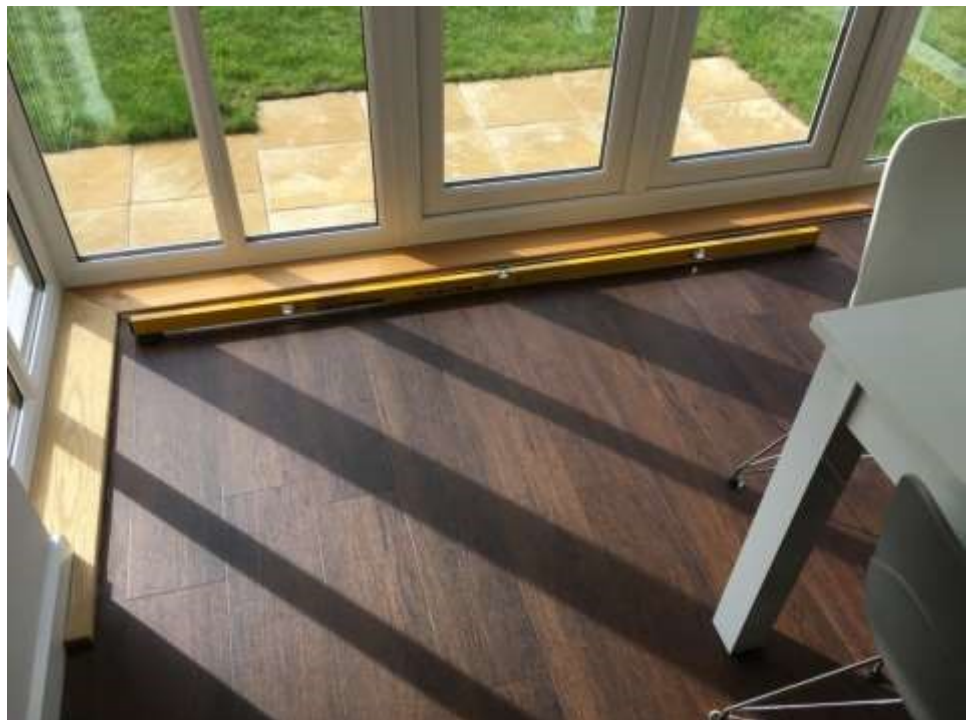
*Floor measured across dining room square bay.*

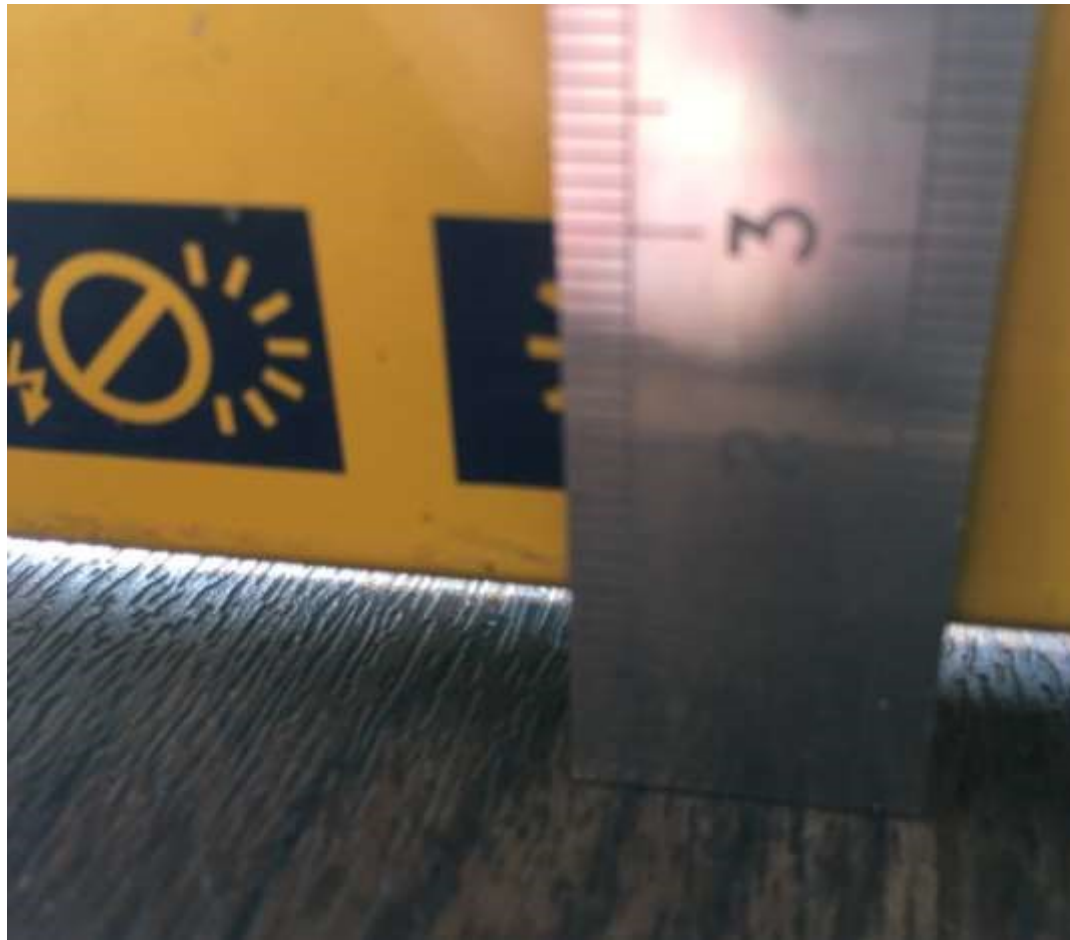
*Dip measured at 12mm. 10mm offsets used below ends of 2m straight edge. NHBC tolerance is +/- 5mm using a 2 metre straight edge with equal offsets. Dip therefore 3mm within allowable tolerance and considered acceptable.*

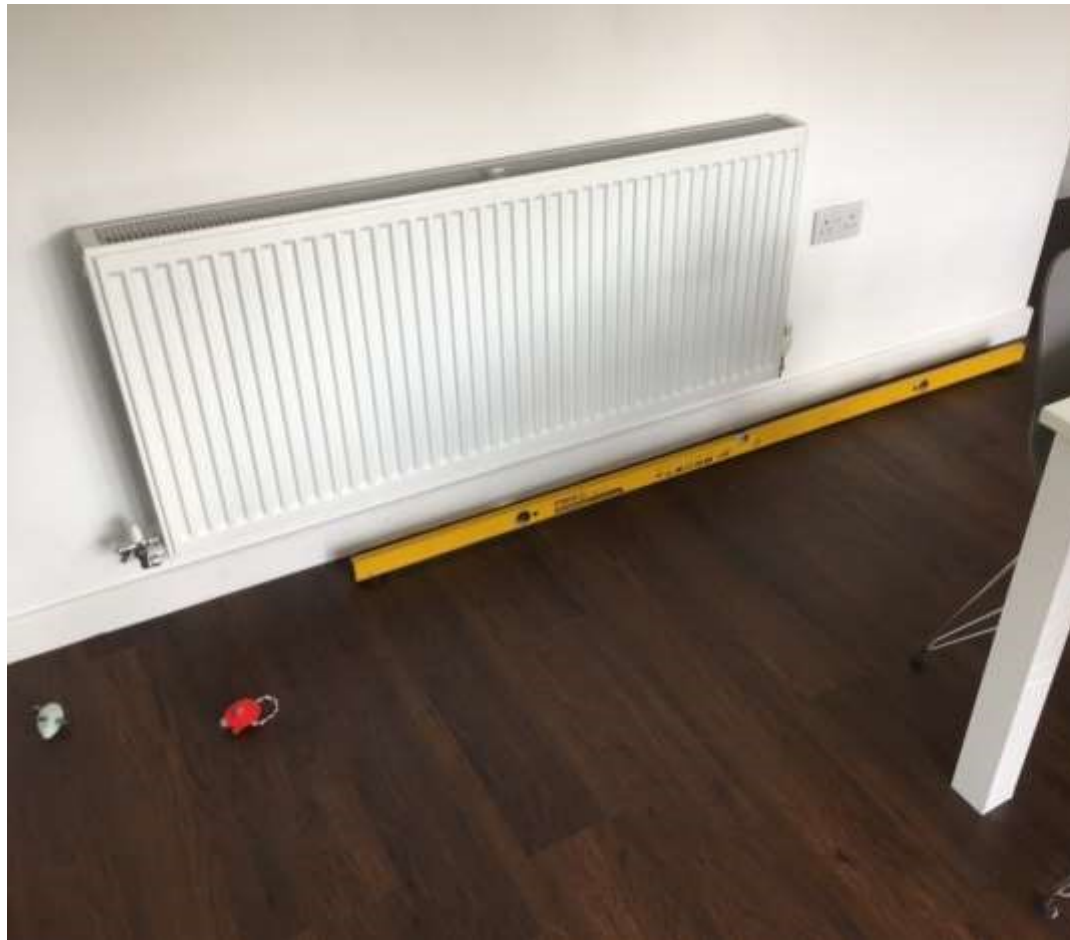
*Floor measured along dining room floor finish perimeter.*

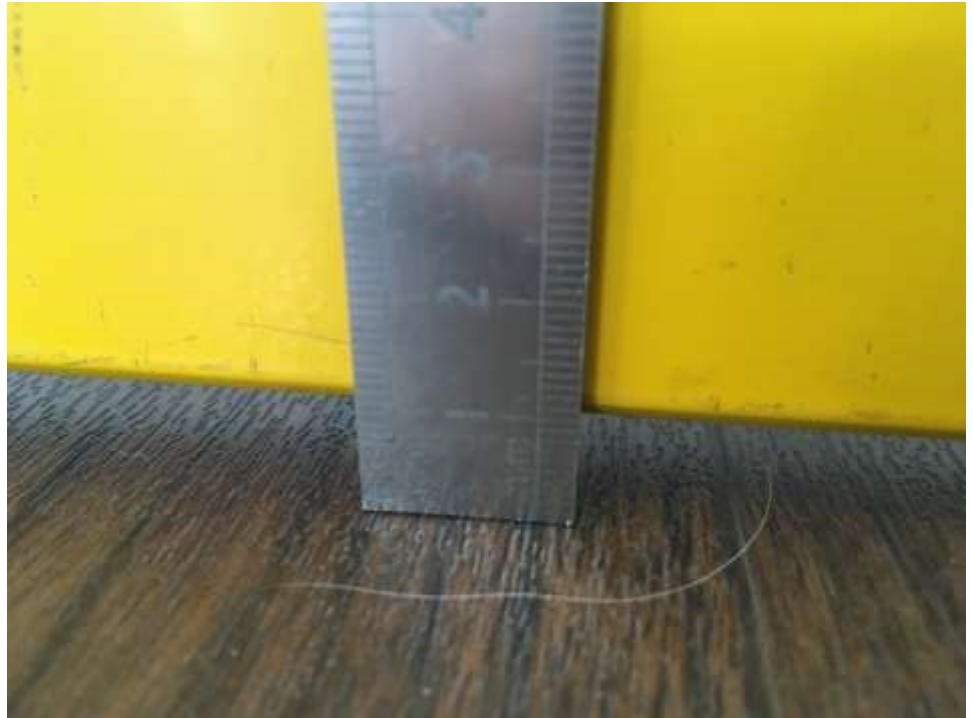
*Dip measured at 10mm. 10mm offsets used below ends of 2m straight edge. NHBC tolerance is +/- 5mm using a 2 metre straight edge with equal offsets. No dip exists and therefore considered acceptable.*

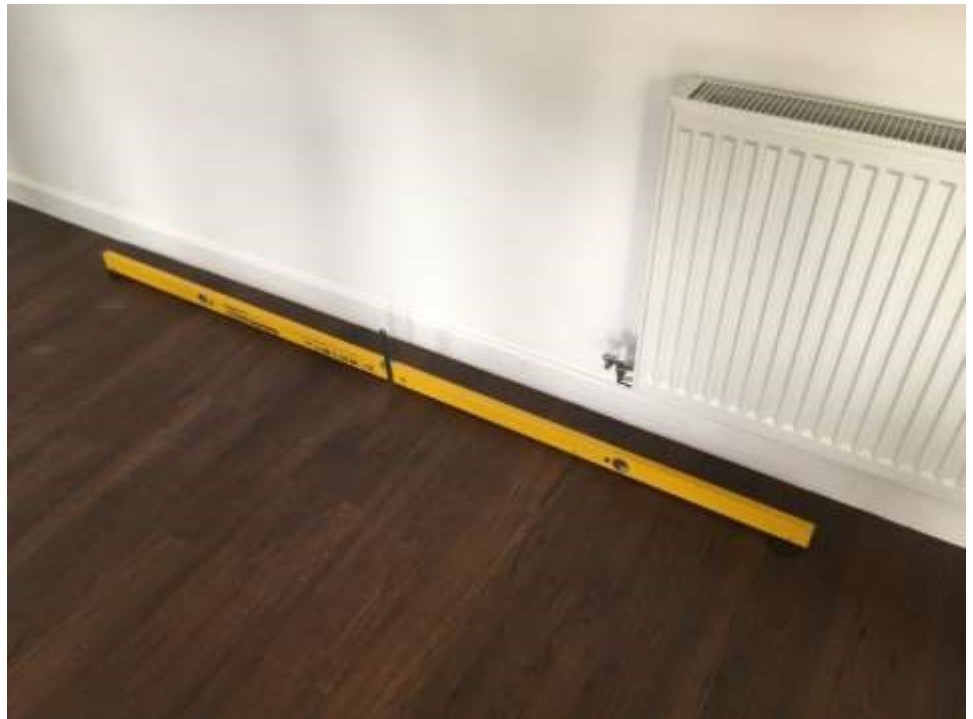
*Floor measured further along dining room floor finish perimeter.*

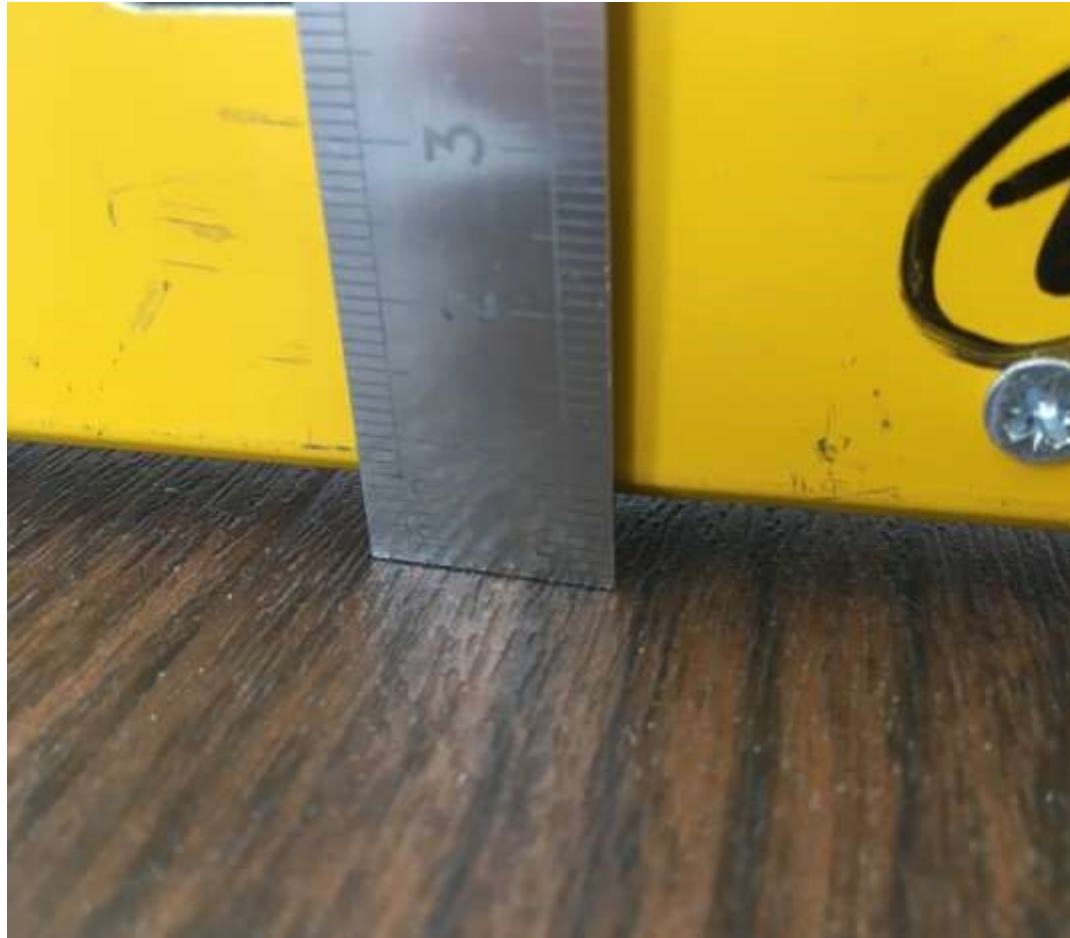
*Rise measured at 6mm. 10mm offsets used below ends of 2m straight edge. NHBC tolerance is +/- 5mm using a 2 metre straight edge with equal offsets. Dip therefore 1mm within allowable tolerance and considered acceptable.*

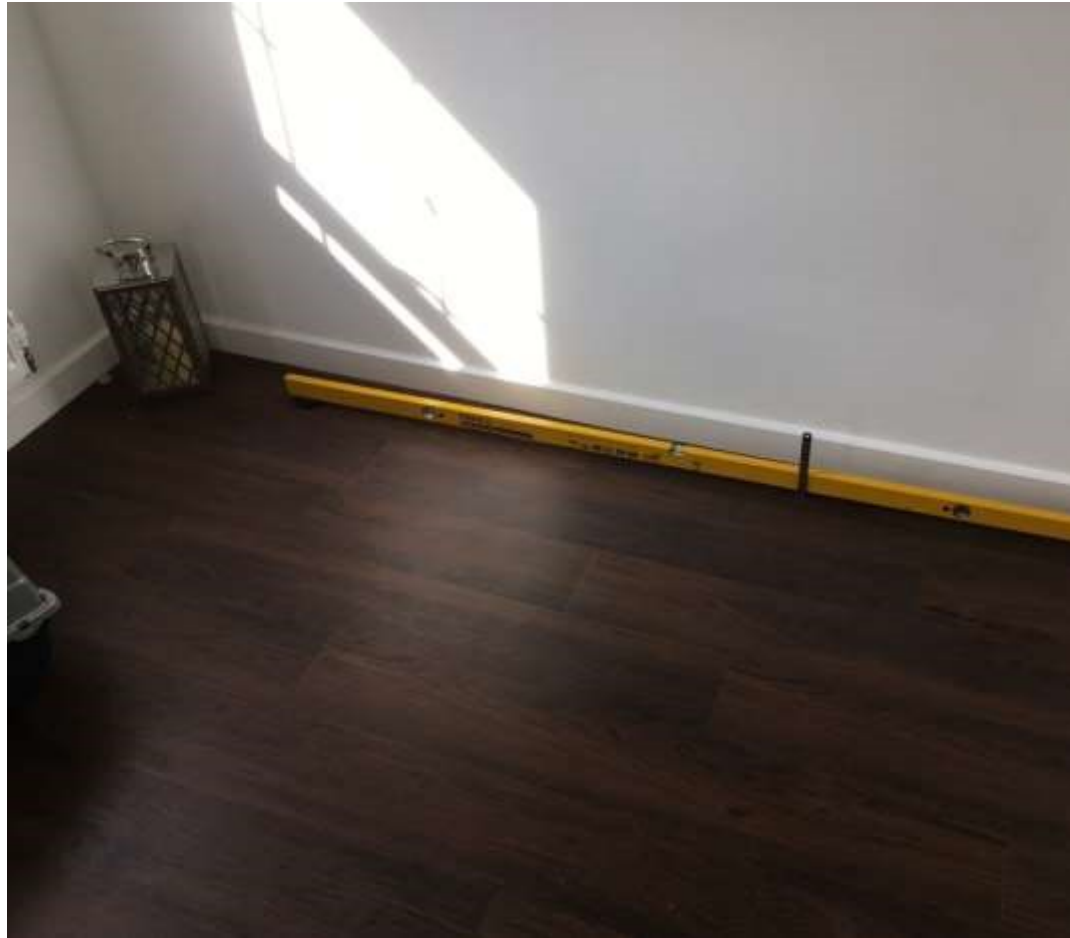
*Floor measured across end of dining room floor finish perimeter.*

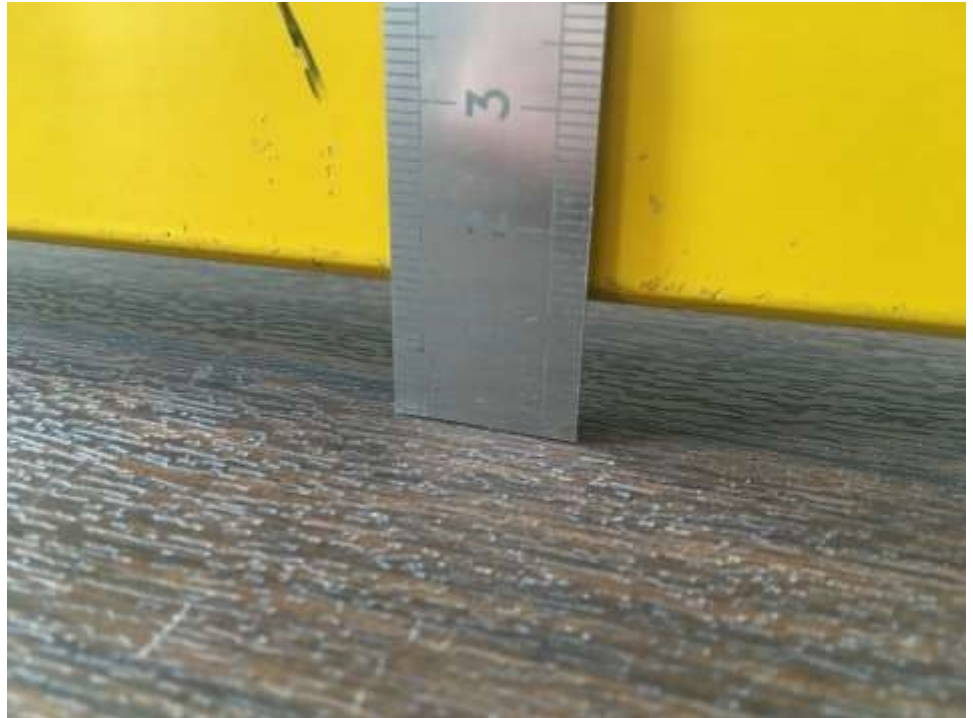
*Dip measured at 13mm. 10mm offsets used below ends of 2m straight edge. NHBC tolerance is +/- 5mm using a 2 metre straight edge with equal offsets. Dip therefore 2mm within allowable tolerance and considered acceptable.*

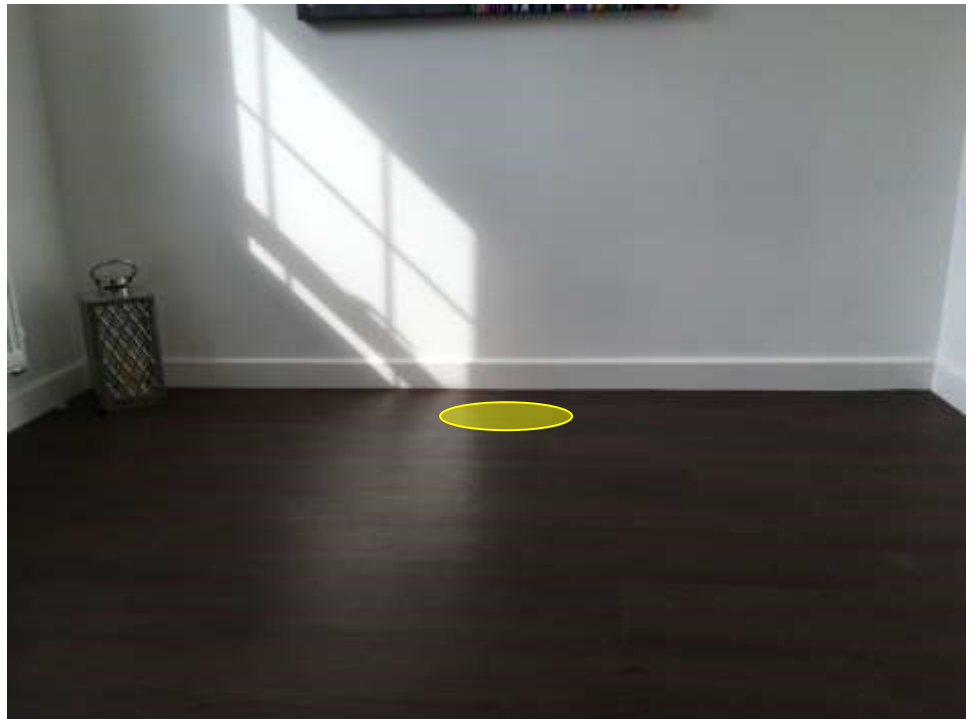
*Visual appearance of Amtico floor finish against skirting lines. Localised hump in floor due to debris below Amtico floor present to area highlighted.*

Mr Ball also pointed out a localised bump in the Amtico floor in the dining room, caused by some debris below the surface. This area is highlighted in the above photograph.

In addition, the localised debris below the Amtico floor in the dining room where highlighted in the above photograph should be removed by the builder.

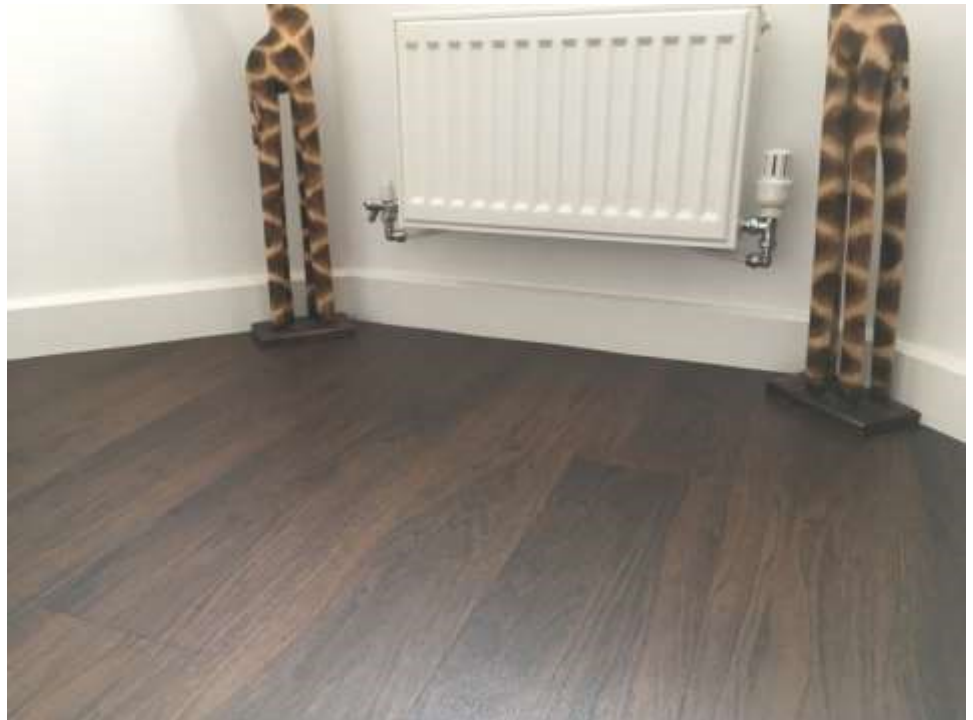
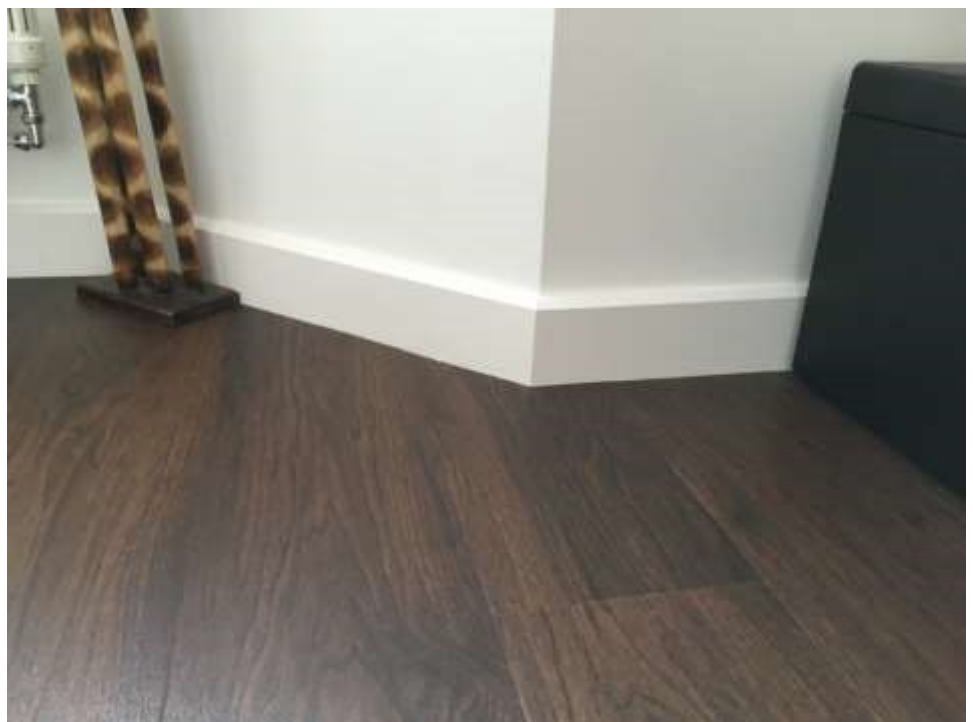
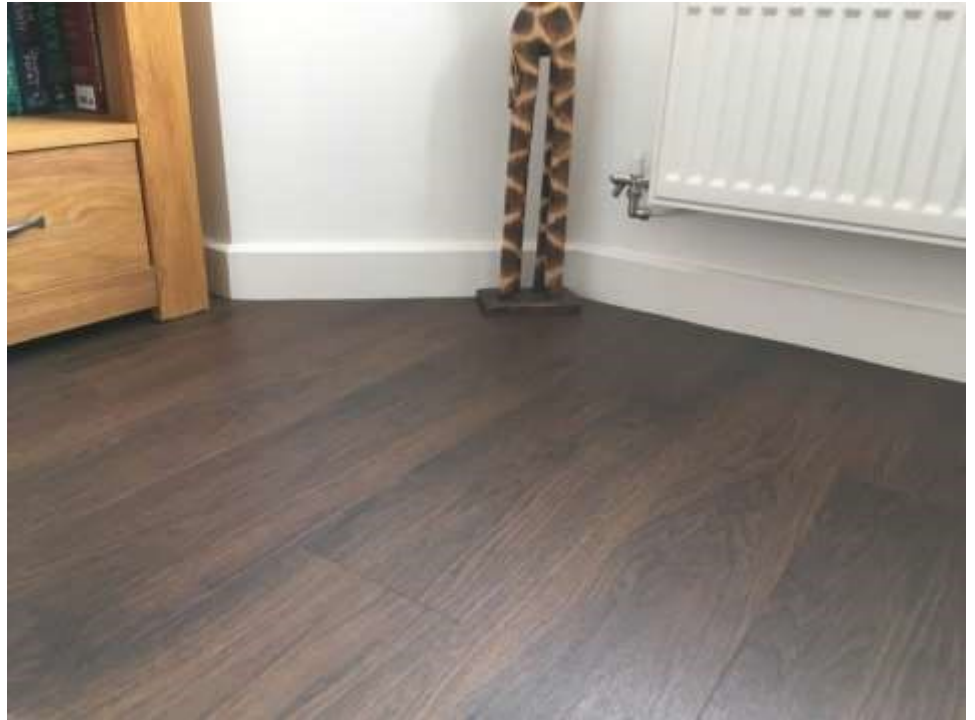
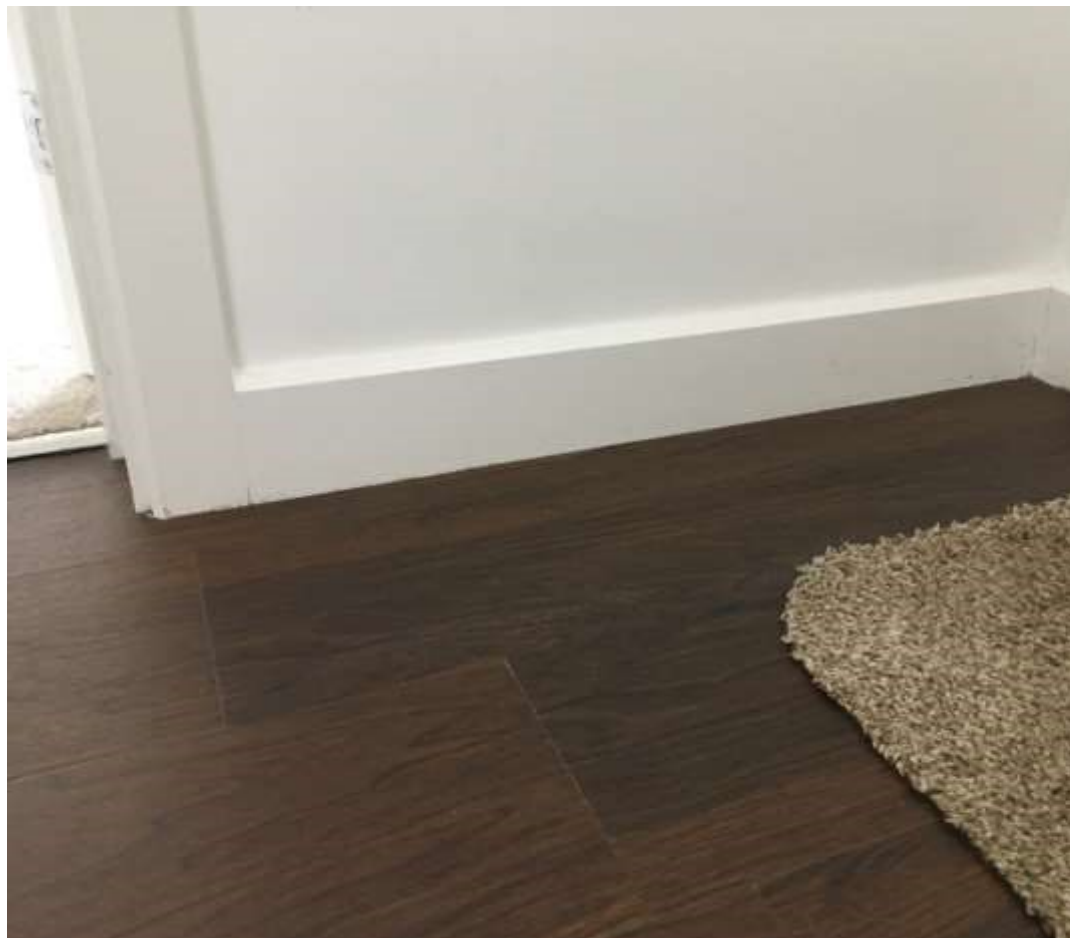
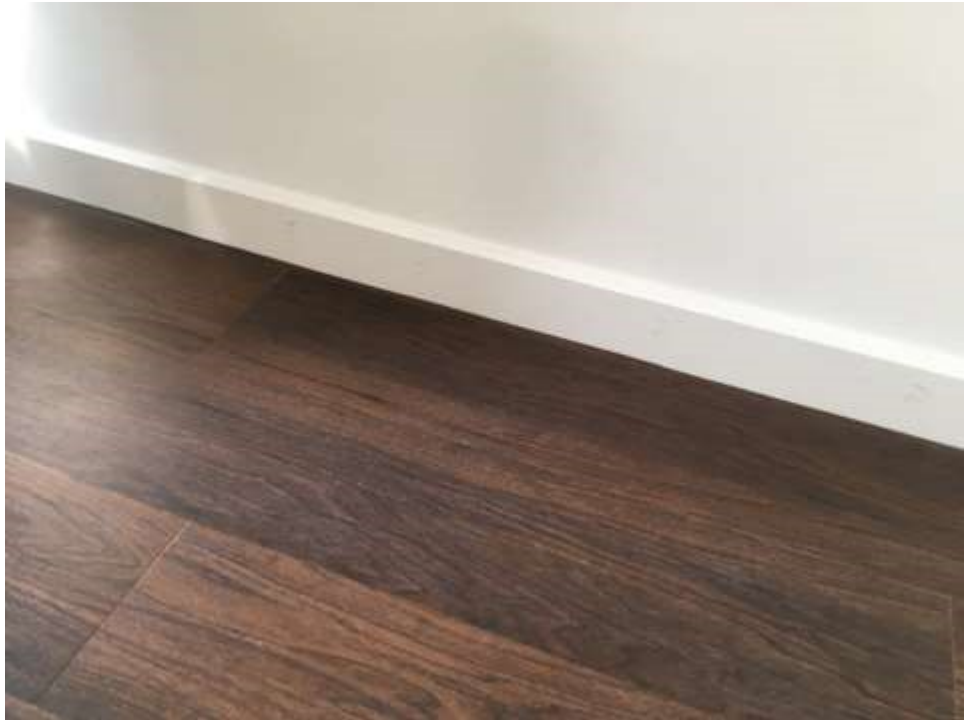
*Visual appearance of Amtico floor finish against skirting lines.*
