***INSPECTION REPORT***

REPORT COMPRISING OBSERVATIONS AND FINDINGS IN RELATION TO EXTERNAL ASPECTS OF:

**PLOT 25 – [REDACTED]**

Date: 04/01/2023

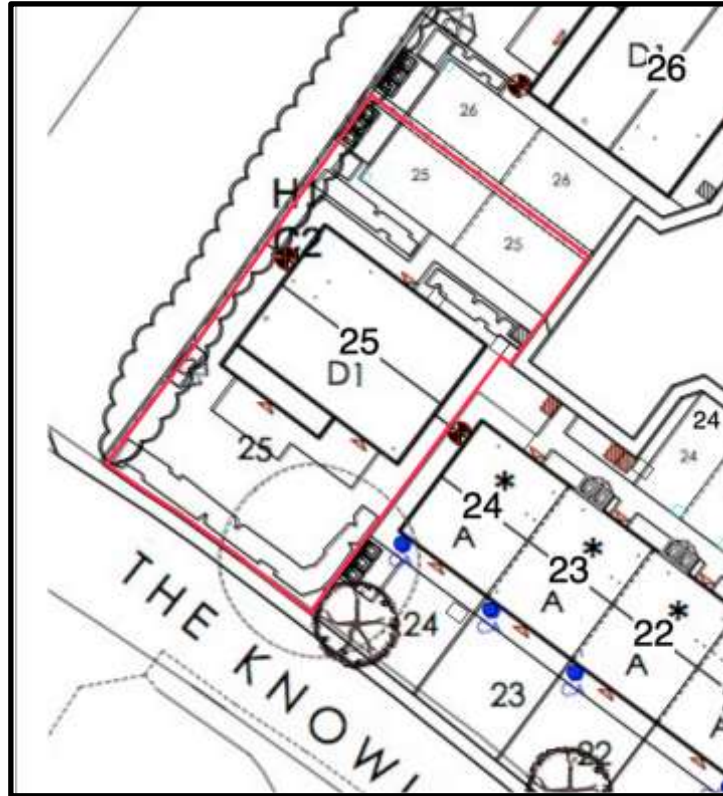
**Figure 1.1 – Supplied drawing showing Plot 25**

As part of the information and enquires pack the homeowners received prior to exchange of contracts, a drawing showing the Plot layout was provided by the developer, **Figure 1.1**. This is the drawing that the homeowners signed and agreed to buy.

When comparison between the drawing provided and what the developer has produced is made, many significant differences can be seen. These are notably:

- The presence of a 'bin store' at the end of the driveway in the drawing - ***this has not been provided to Plot 25***
- The access to Plot 25 coming from the road – ***access to Plot 25 has not been constructed in this way***
- The absence of a retaining wall in the rear garden – ***Plot 25 has a retaining wall in the rear garden returning down the side of the house***
- The absence of a retaining wall at the end of the driveway – ***Plot 25 has a retaining wall at the end of the driveway***
- The presence of a garden at the rear separate to the patio area – ***this has not been provided to Plot 25***

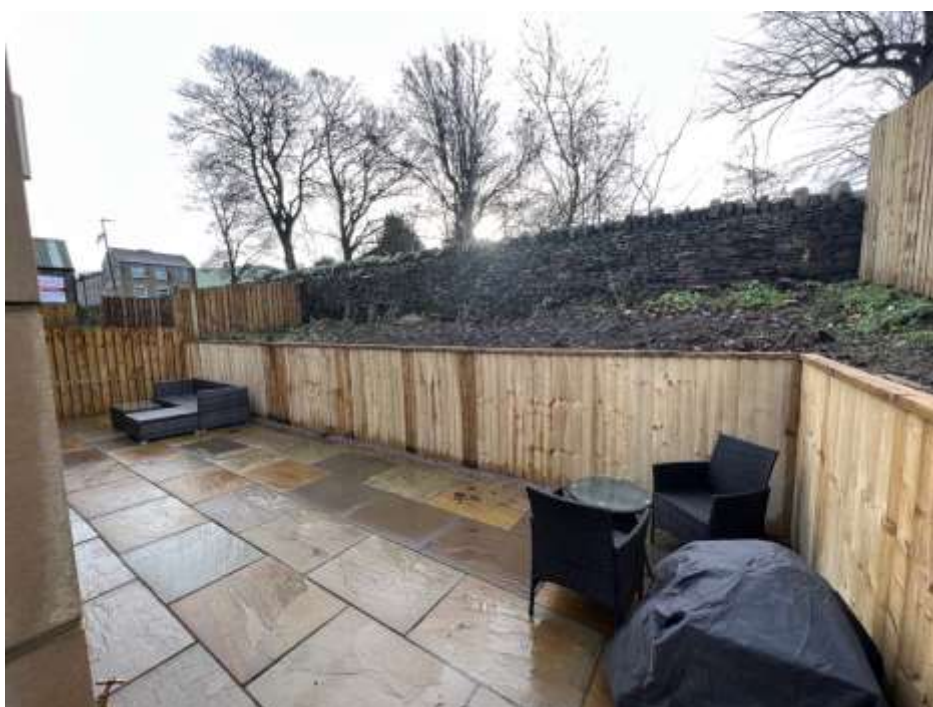
**Figure 1.3 As-constructed rear garden**

As part of the sales brochure, a specification was provided, **Figure 1.2**, which states that as part of the specification a rear turfed garden would be provided. Plot 25 has not been provided with a turfed area to the rear, **Figure 1.3**.

Notification of these changes to plan or specification **were not** communicated to the homebuyers, and in their prejudice these changes have altered the quality and value of the property.

The inclusion of a turfed area was specifically asked about at reservation, and the homeowners were told it was in the specification and will be included. At this point it seems the most sensible approach would be to make the area above the retaining wall at the rear into a garden, with appropriate guarding onto the wall.

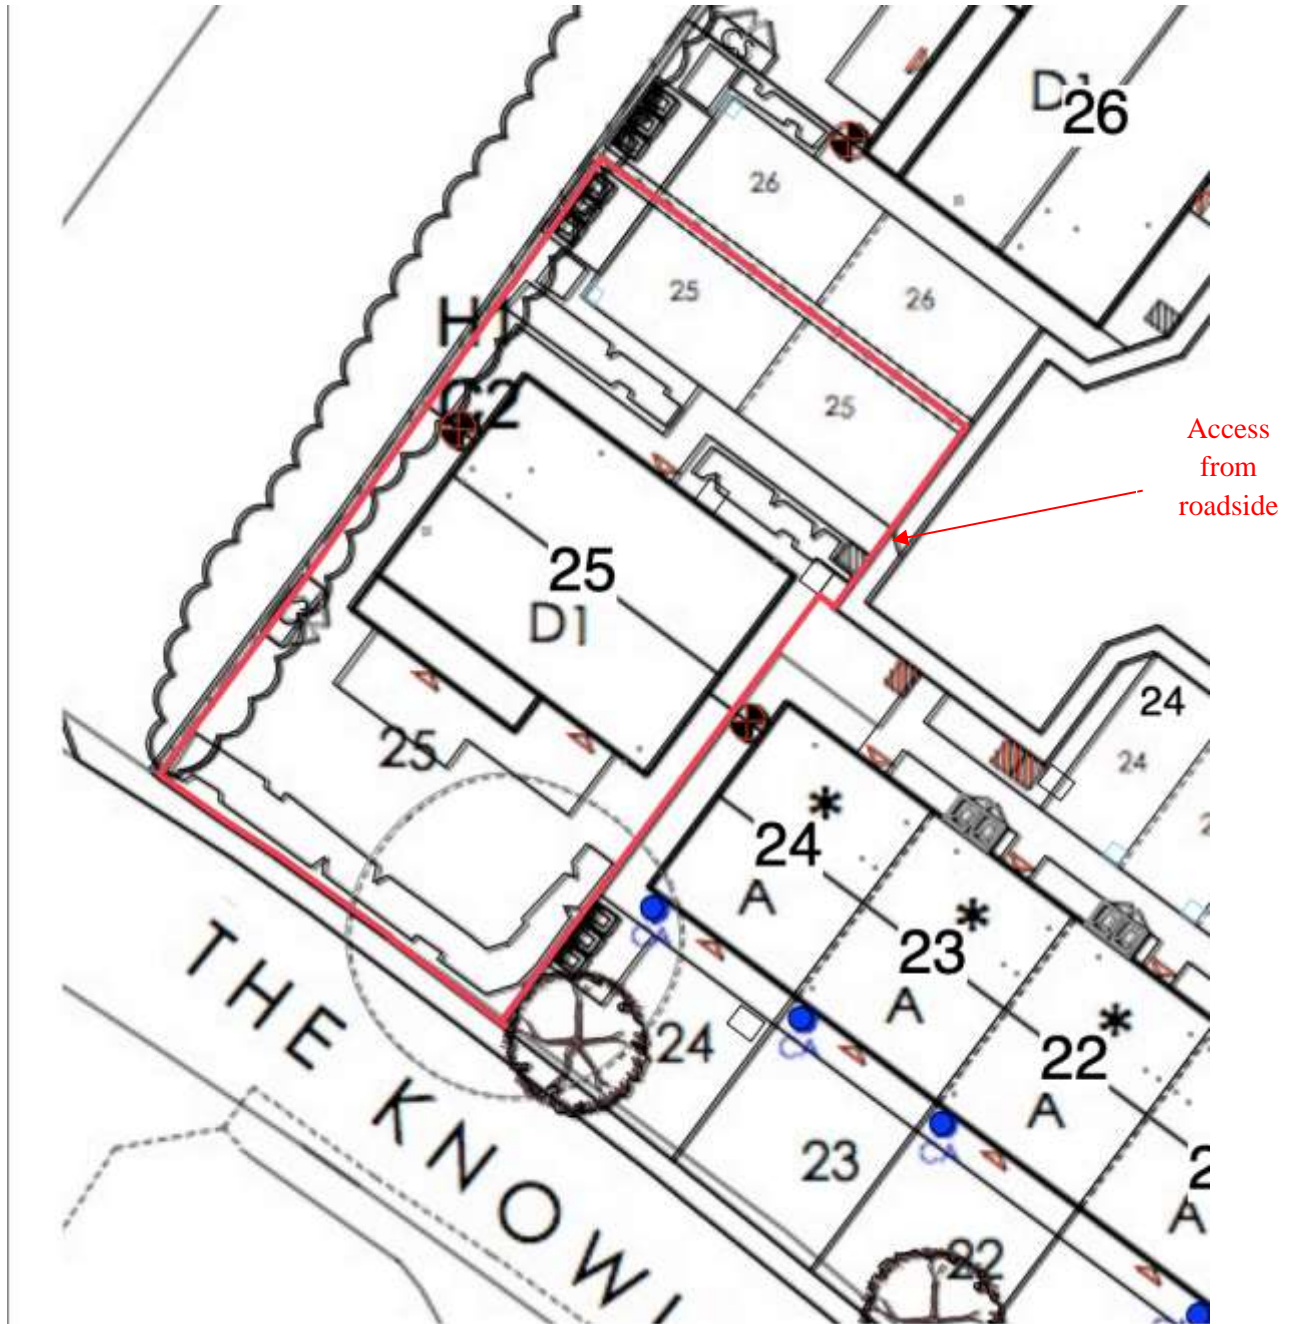
**Figure 2.2: Drawing provided to homeowner - Annotated**

The drawing provided to the homeowners during the purchase of the property, **Figure 2.2**, depicts the access route coming from the road, mitigating the need for the additional 900mm walkway. In reality, the access has been constructed from the far side of the driveway, **Figure 2.3**, therefore the driveway forms part of the access route. Had the access been constructed as shown in drawing provided to the homeowners, this issue would not have arisen. It is not clear why the deviation from the drawing provided to the homeowners has occurred.

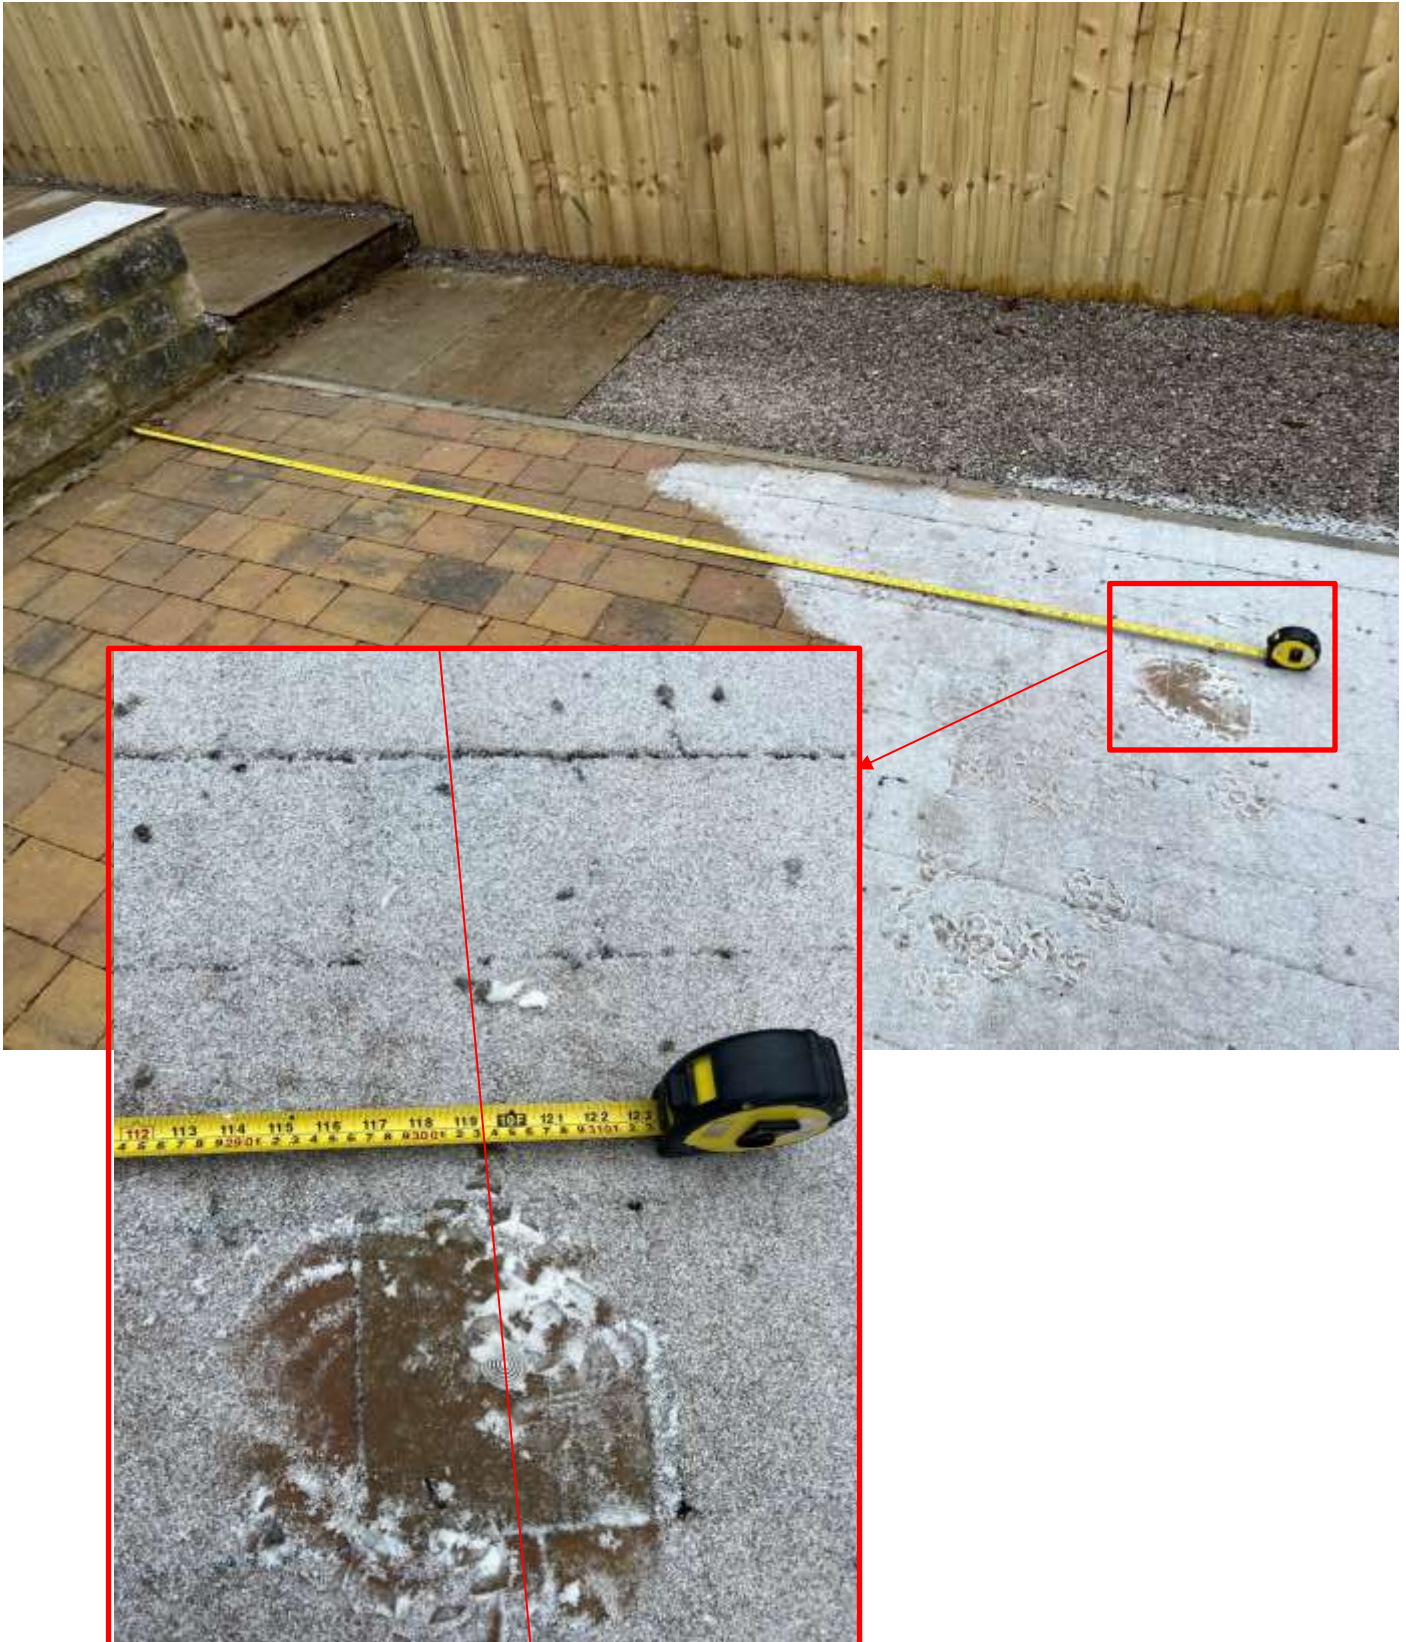
Inspection of the driveway revealed the width to be ranging between 3.0m and 3.1m, **Figure 2.4**, and as such it does not conform to building regulations. Considering the adjacent plot (Plot 26/No.6) has a driveway of the same dimensions as Plot 25, for consistency, it would not be unreasonable to expect an additional 900mm walkway incorporated onto the current width of the driveway, bringing the total width to approximately 4m.

**Figure 2.4: Driveway width – metal studs indicate end of Plot 25 driveway.**

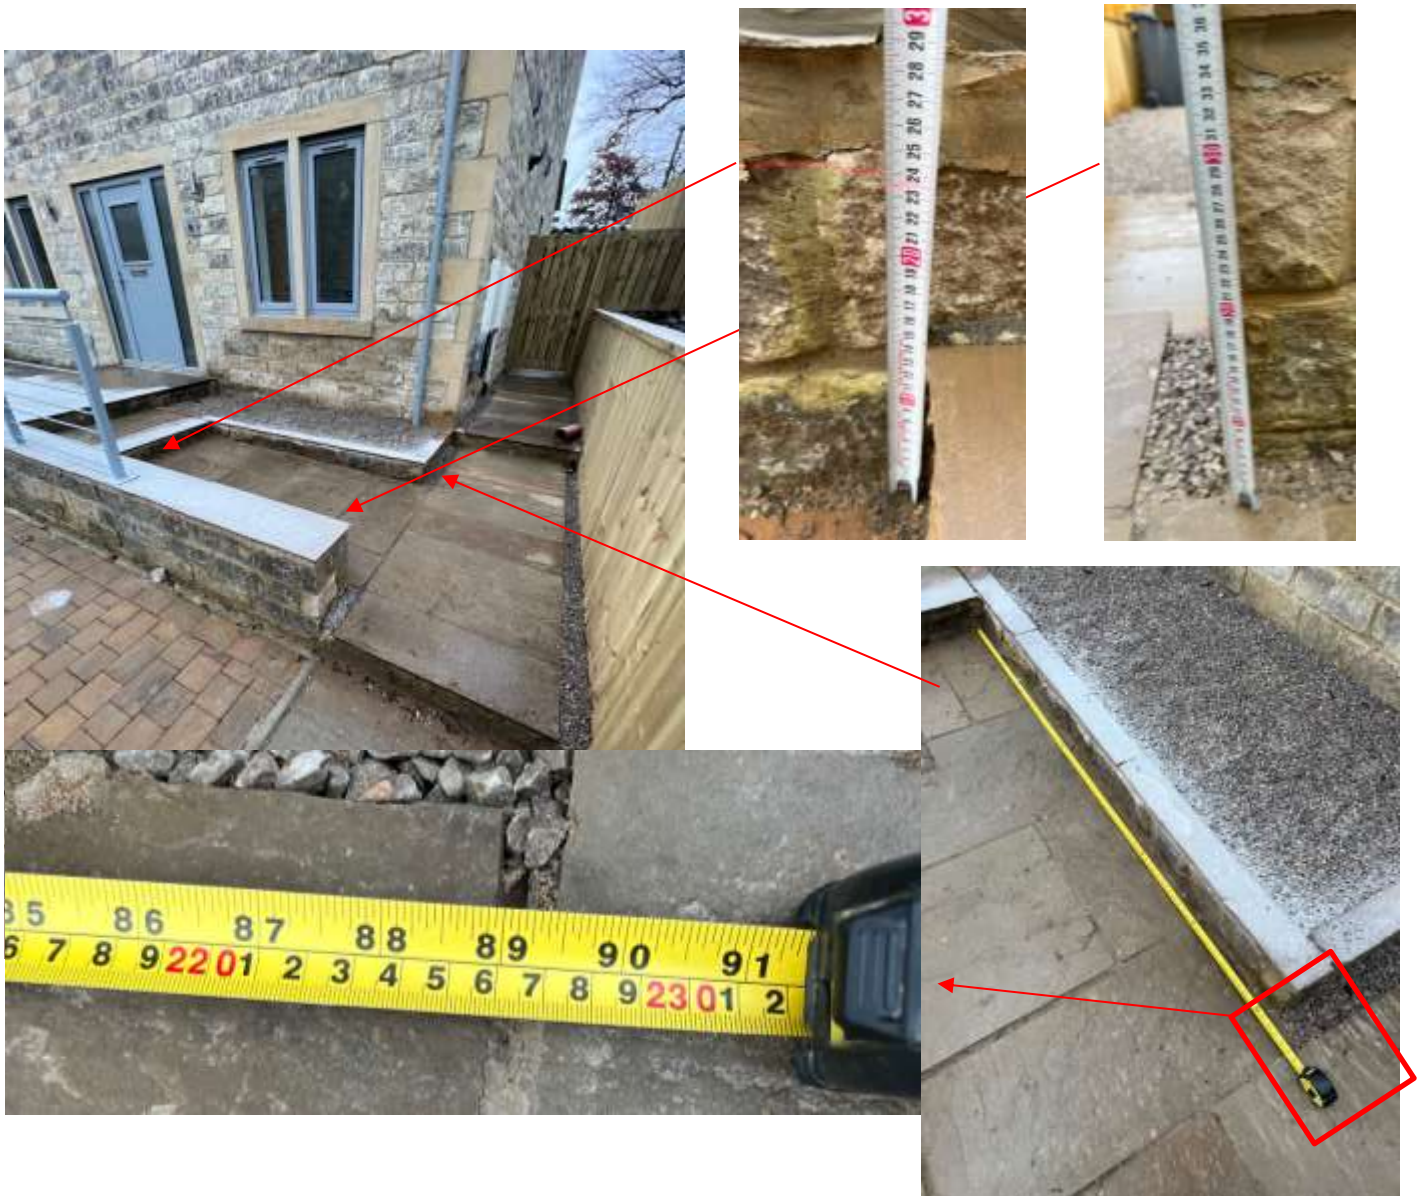
**Figure 3.2: As-constructed access to Plot 25 – with measurements**

On the access route to Plot 25, a flight of two steps have been constructed. The lower landing is not level and is ‘sloped’. Measurements of the rise revealed it to be approximately 71mm and the going to be approximately 2207mm, resulting in a gradient of approximately 1:31, **Figure 3.2**. This does not conform with building regulations.

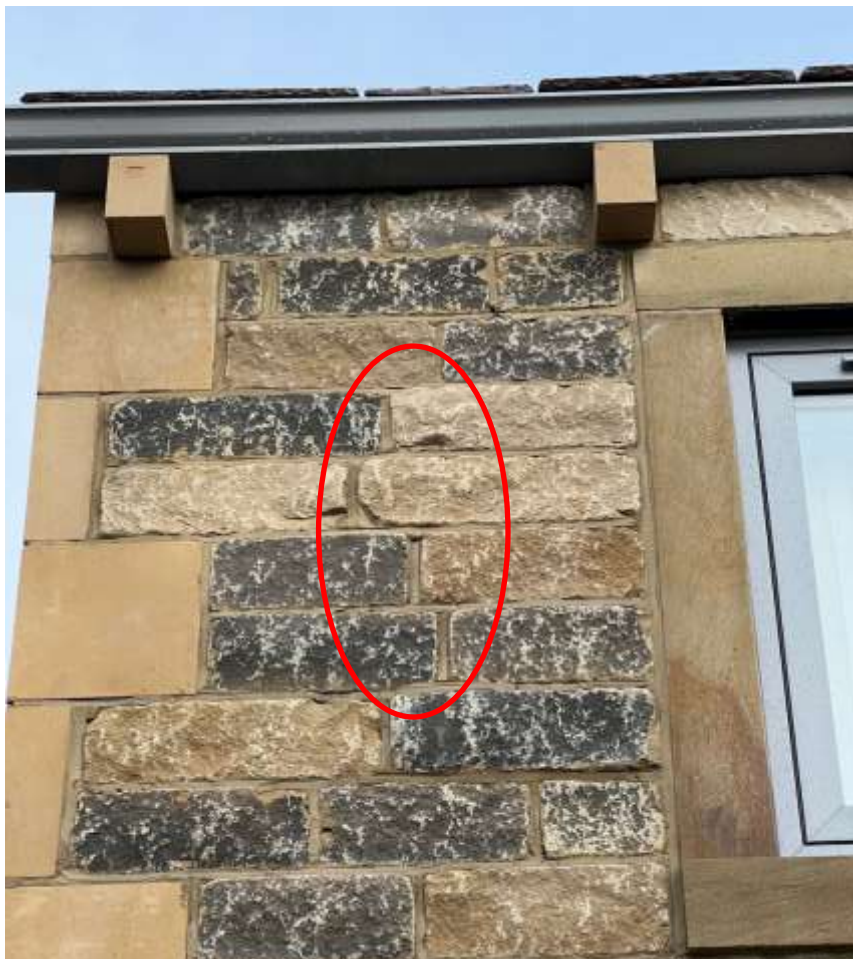
Inspection of Plot 25 revealed numerous areas on the stonework where the bond did not comply with *BS EN 1996-1-1:2005*, to the extent that it is not possible for succinct recording and reporting of the areas within this report. Instead, a representative image is shown in **Figure 4.2**.

**Figure 4.2 Plot 25 rear elevation – right corner when viewed from front of house – representative image**

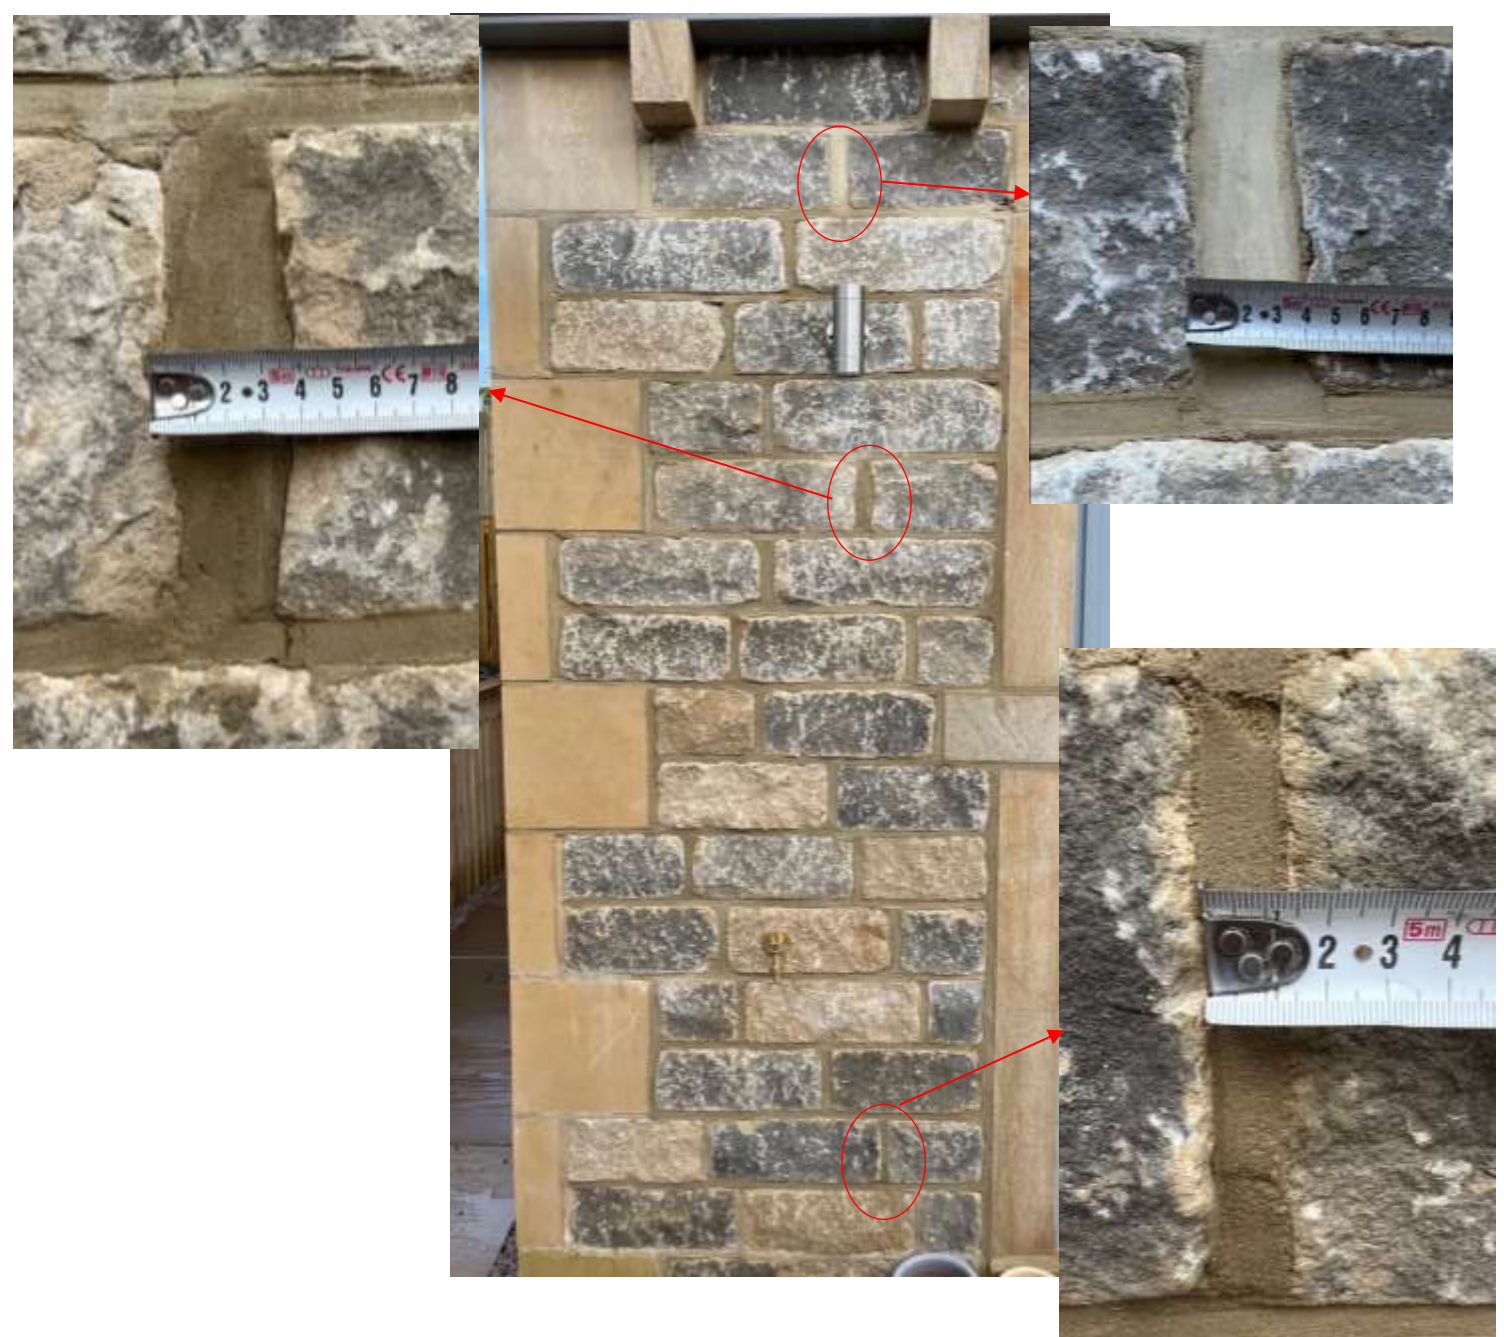
Inspection of the perpend joints on the stonework on Plot 25 revealed an extensive number perpend joints greater than 15mm. Again, such a large volume of out of tolerance perpend joints made it very difficult to succinctly record them within this report. Some representative images are shown in **Figure 4.4**. Using one of the smaller perpend joints as reference (shown below) it is evident that the majority of perpend joints on the photographed pillar are out of tolerance. This is representative of the stonework on the entirety of Plot 25.

**Figure 4.4 Out of tolerance perpend joints – with measurements**

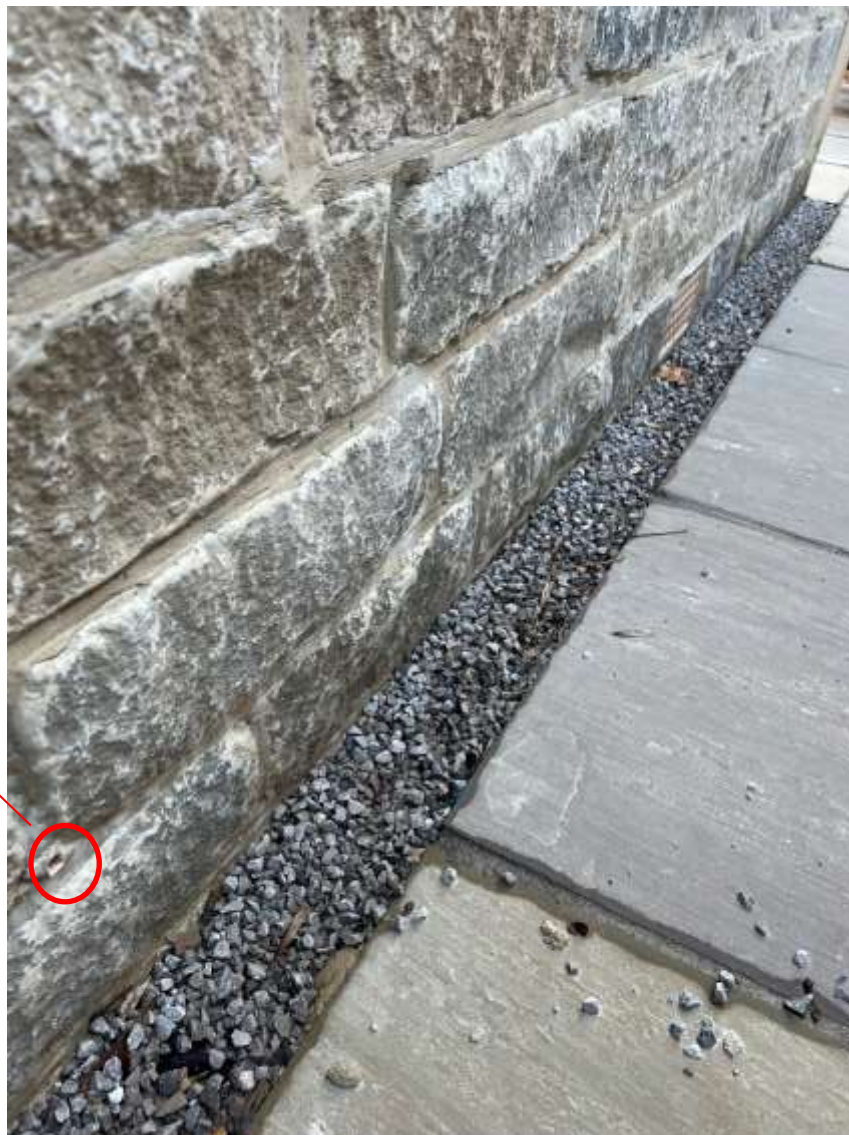
At several locations on plot 25 inadequate weep-holes have been used in construction, particularly at the DPC course close to ground level, where they have been missed or placed further apart than the 900mm limit. Representative image, **Figure 4.6**.

**Figure 4.6** Representative image showing insufficient weep-holes

Last weep-vent on  
that stretch of  
stonework

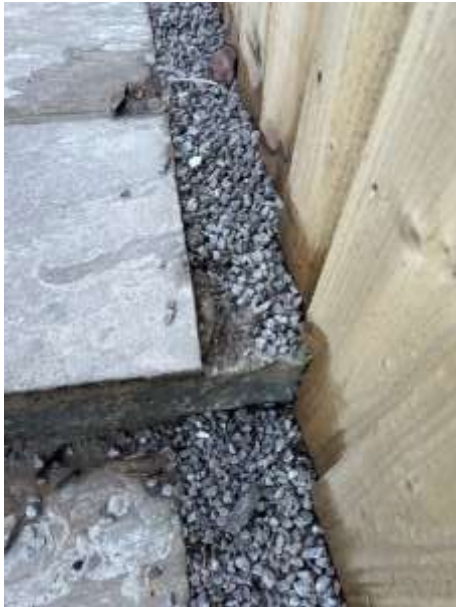
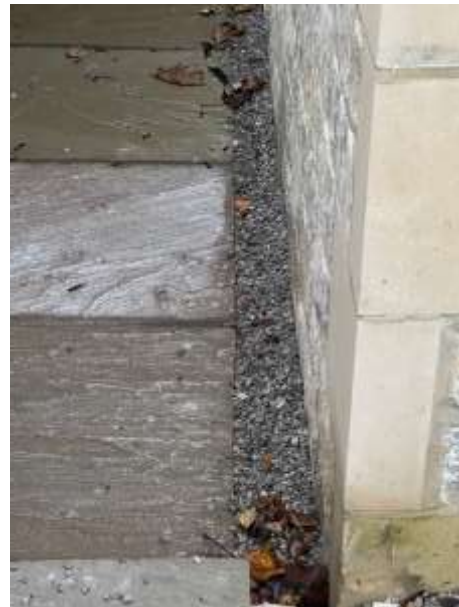
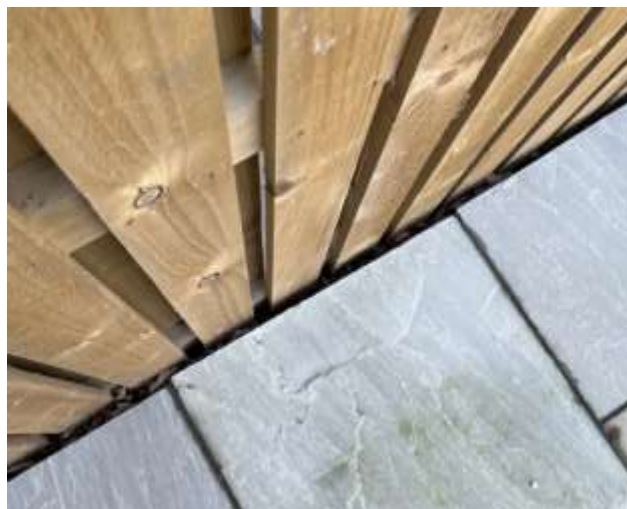
No edgings have been used on the entirety of the paths on Plot 25, representative images, **Figure 5.2**.

**Figure 5.2** Representative images showing lack of Edgings used

The lack of edgings on the pathways around Plot 25 has resulted in none of the paths being square or true to the dwelling structure, almost as though those doing the work did not possess a string line, pins, square and tape measure, hardly good workmanlike conduct.

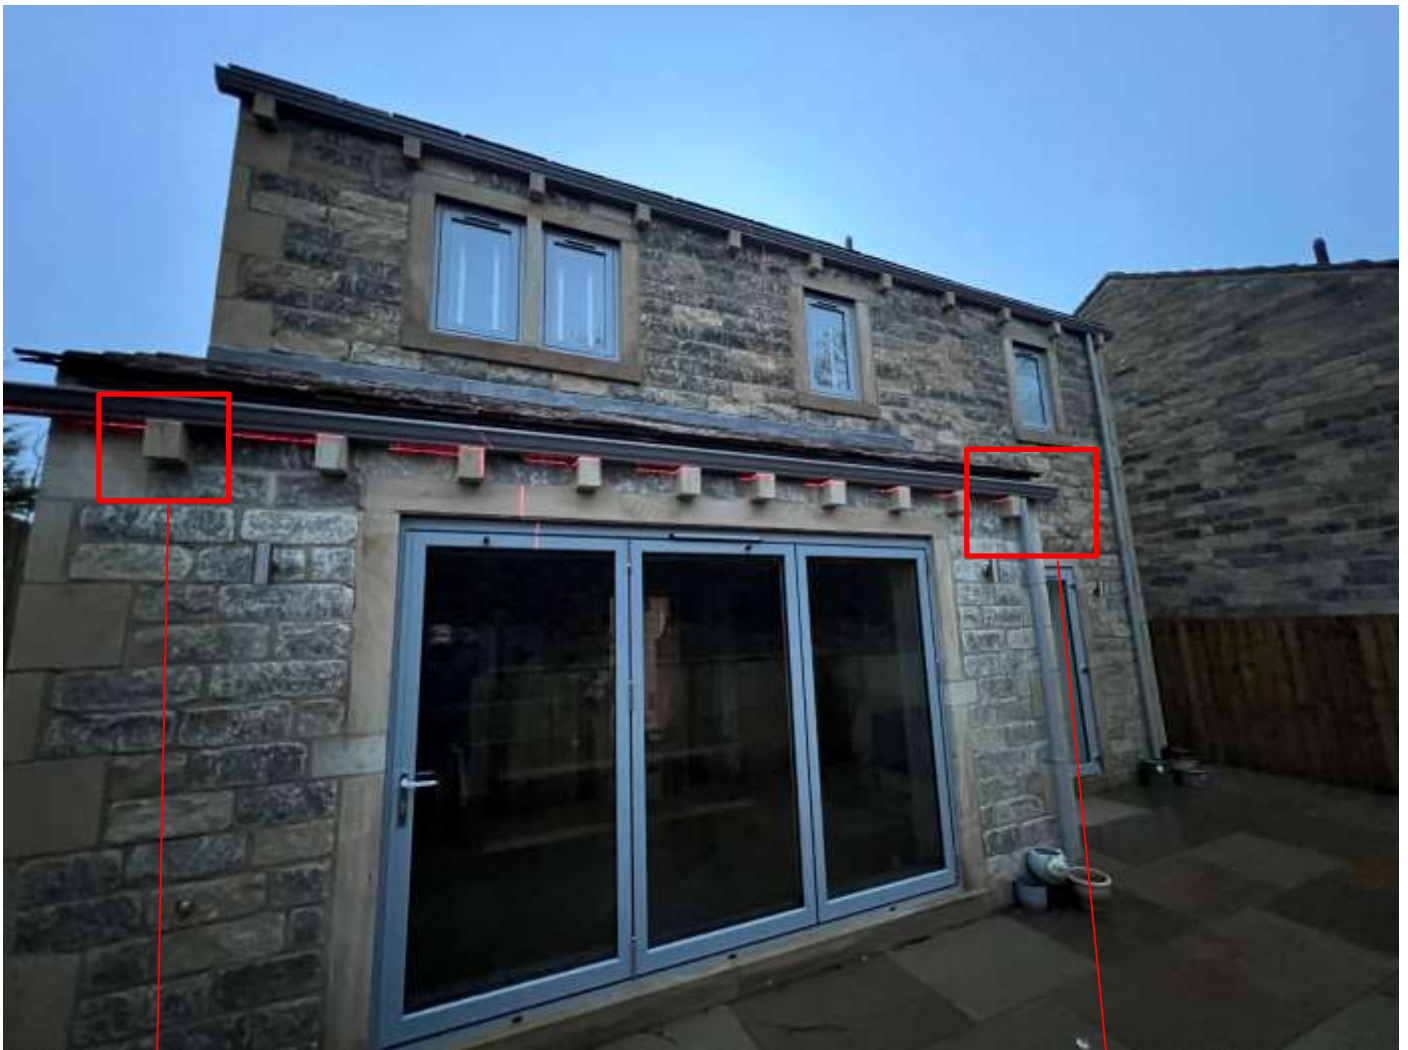
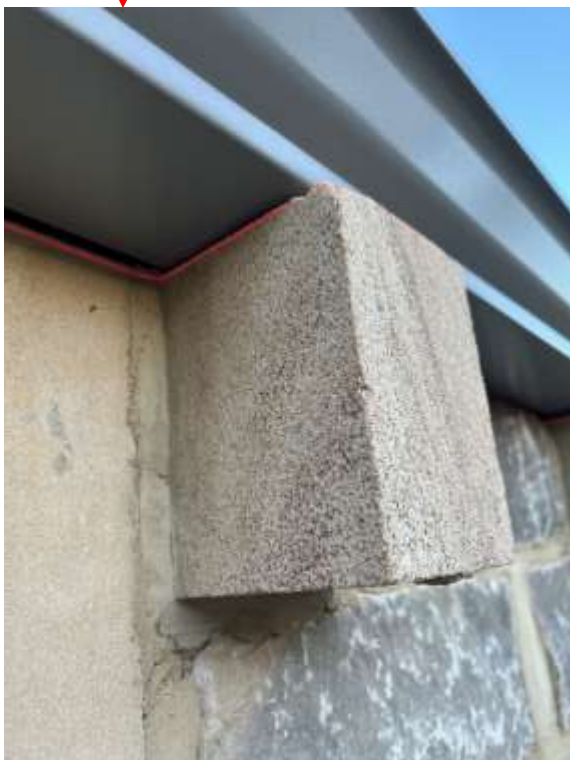
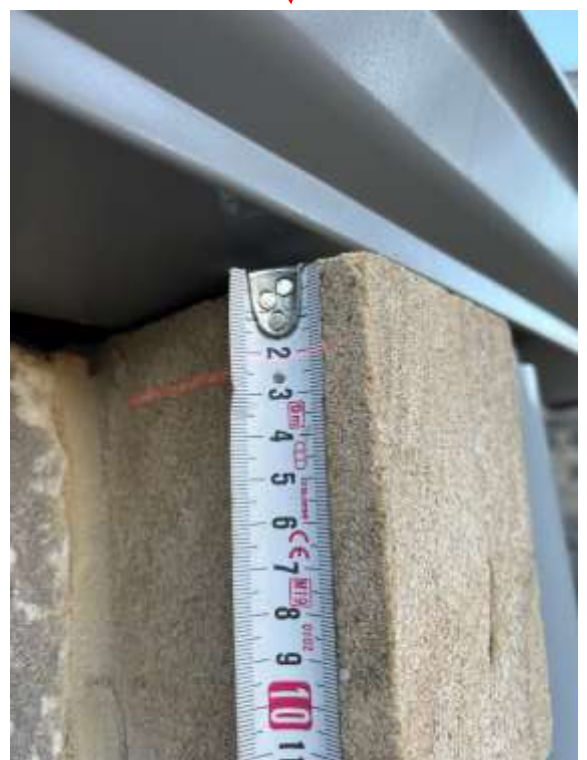
**Figure 5.3 Lean-to at the rear of the property**

Examination of the construction of the lean-to at the rear of the property revealed it to be built approximately 20mm out of level, **Figure 5.3**. This also presents an issue as the corbel stones used to support the gutter are climbing towards the fall pipe.

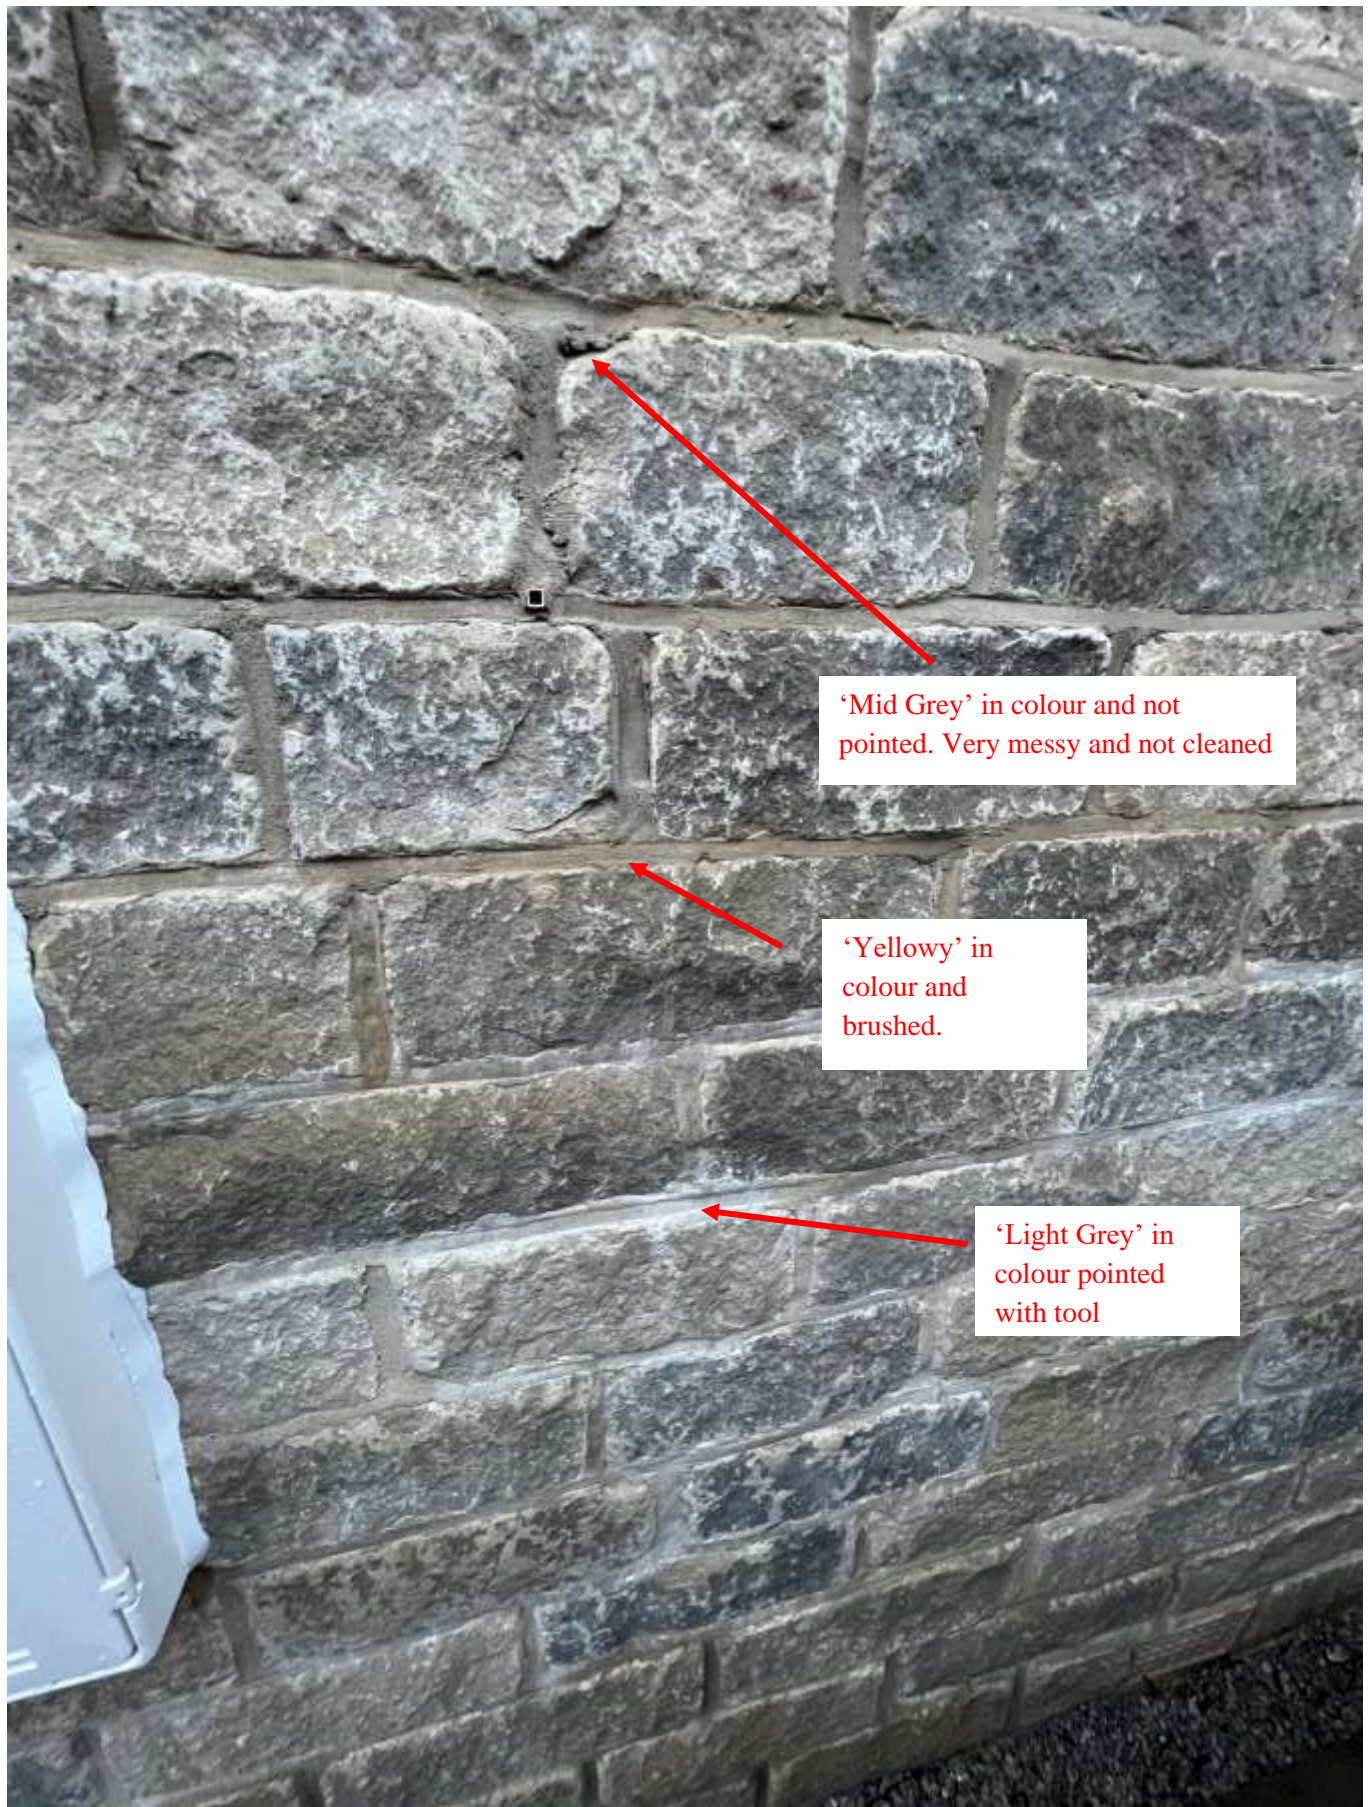
The quality of the mortar and pointing is extremely inconsistent across the entirety of Plot 25. Differences in mortar colour and pointing quality are shown in a representative image, **Figure 5.4**.

**Figure 5.4** Representative images showing differences in mortar colour and poor pointing

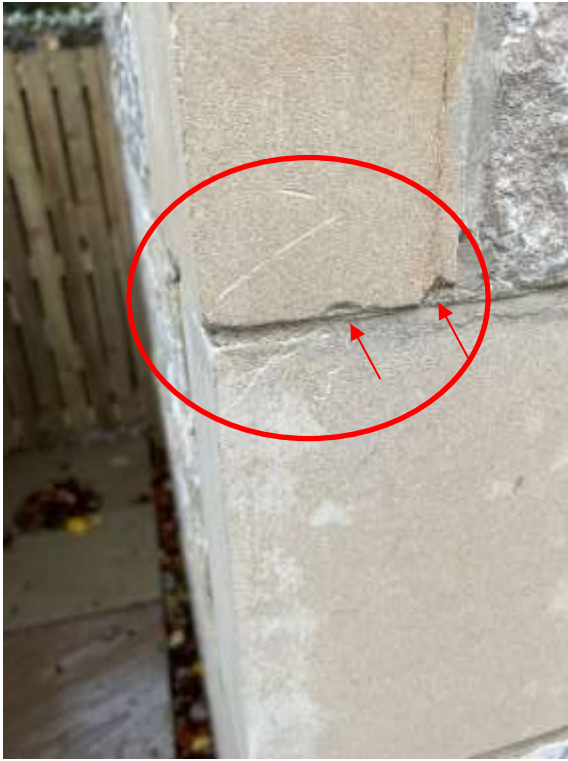
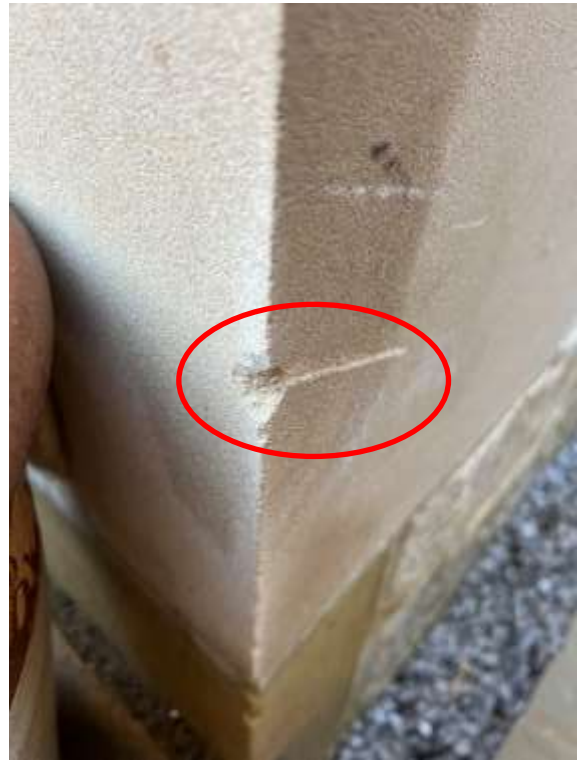
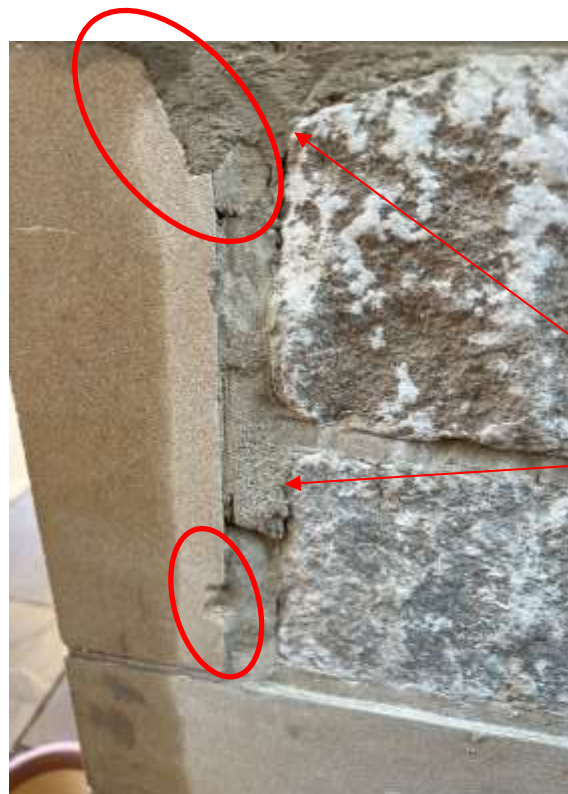
Many of the quoin stones used on the construction of Plot are chipped and or scratched. Representative images, **Figure 5.5.**

**Figure 5.5 Representative images showing damage to quoins**

Further example of poor and inconsistent pointing

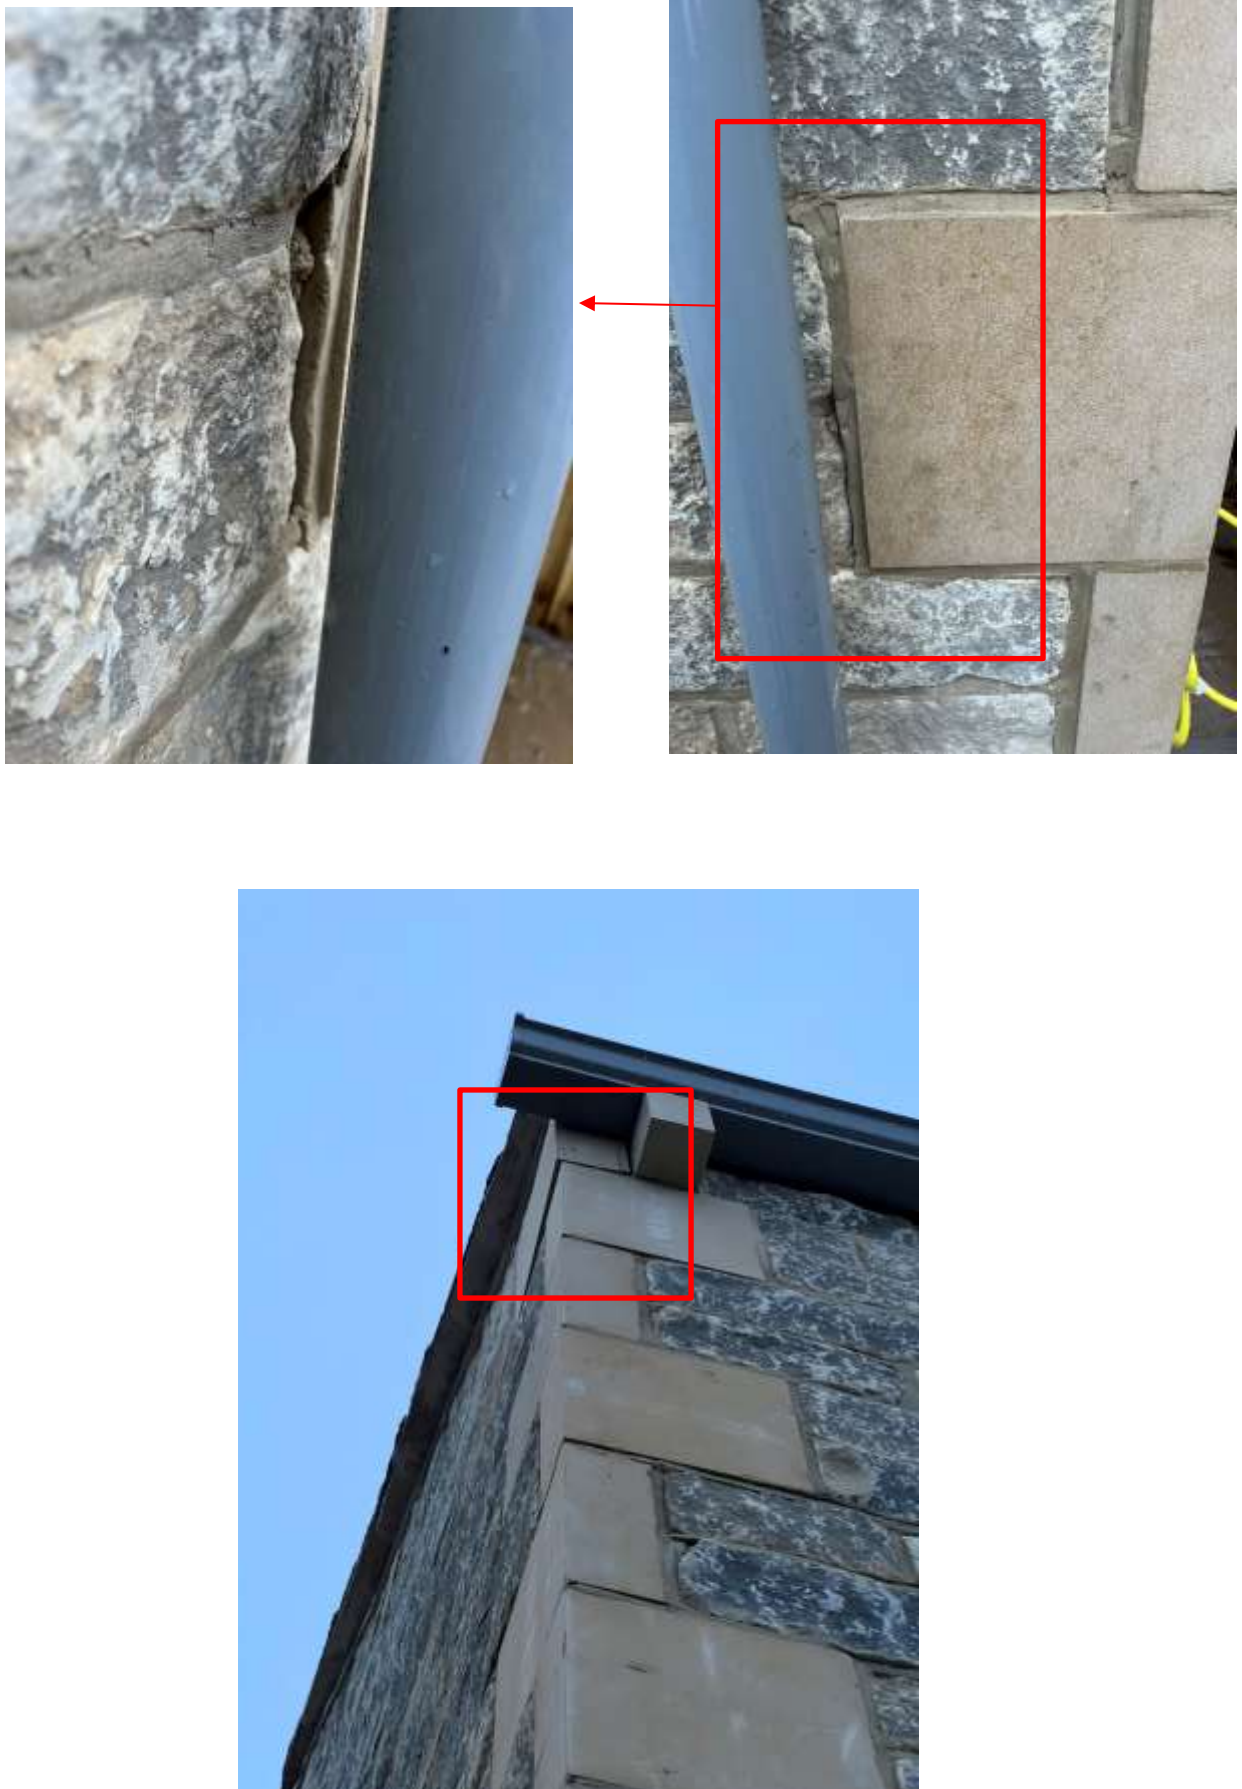
The alignment of the quoin stones in relation to the adjacent stonework is also poor in some locations, with some quoin's mis-aligned or coming away from the stonework. Representative images, **Figure 5.6**.

**Figure 5.6 Representative images showing mis-aligned quoins**
