***INSPECTION REPORT***

REPORT COMPRISING OBSERVATIONS AND FINDINGS IN RELATION TO EXTERNAL ASPECTS OF:

**PLOT 25 – [REDACTED]**

Date: 04/01/2023

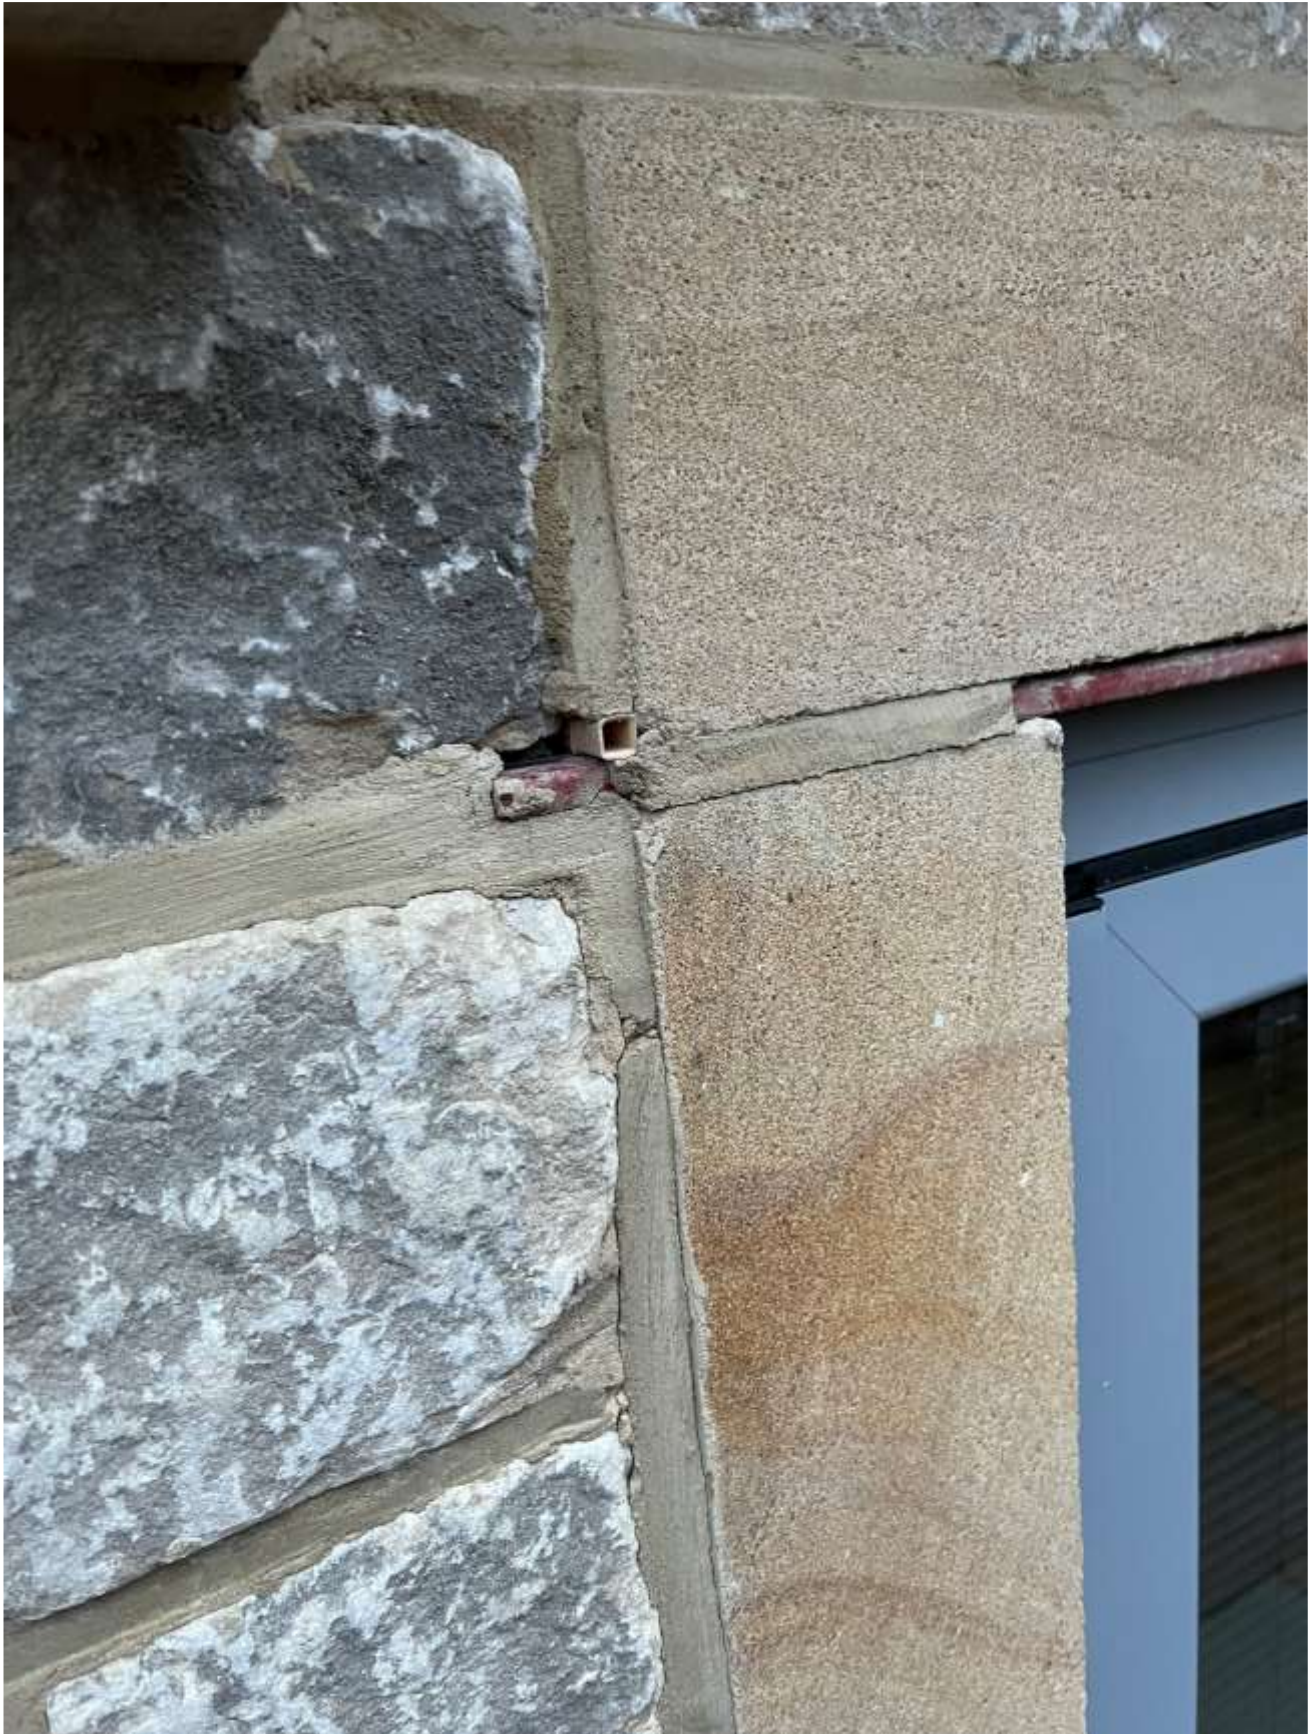
The finish on the steel beam spanning the door opening in the lean-to at the rear of Plot 25 has been left un-painted and as primed with red oxide primer. The steel is also not inset back onto the stone/block work to allow for proper pointing, **Figure 5.7**

**Figure 5.7 As primed steel, holes in mortar and poorly pointed. Steel left protruding preventing sufficient pointing.**

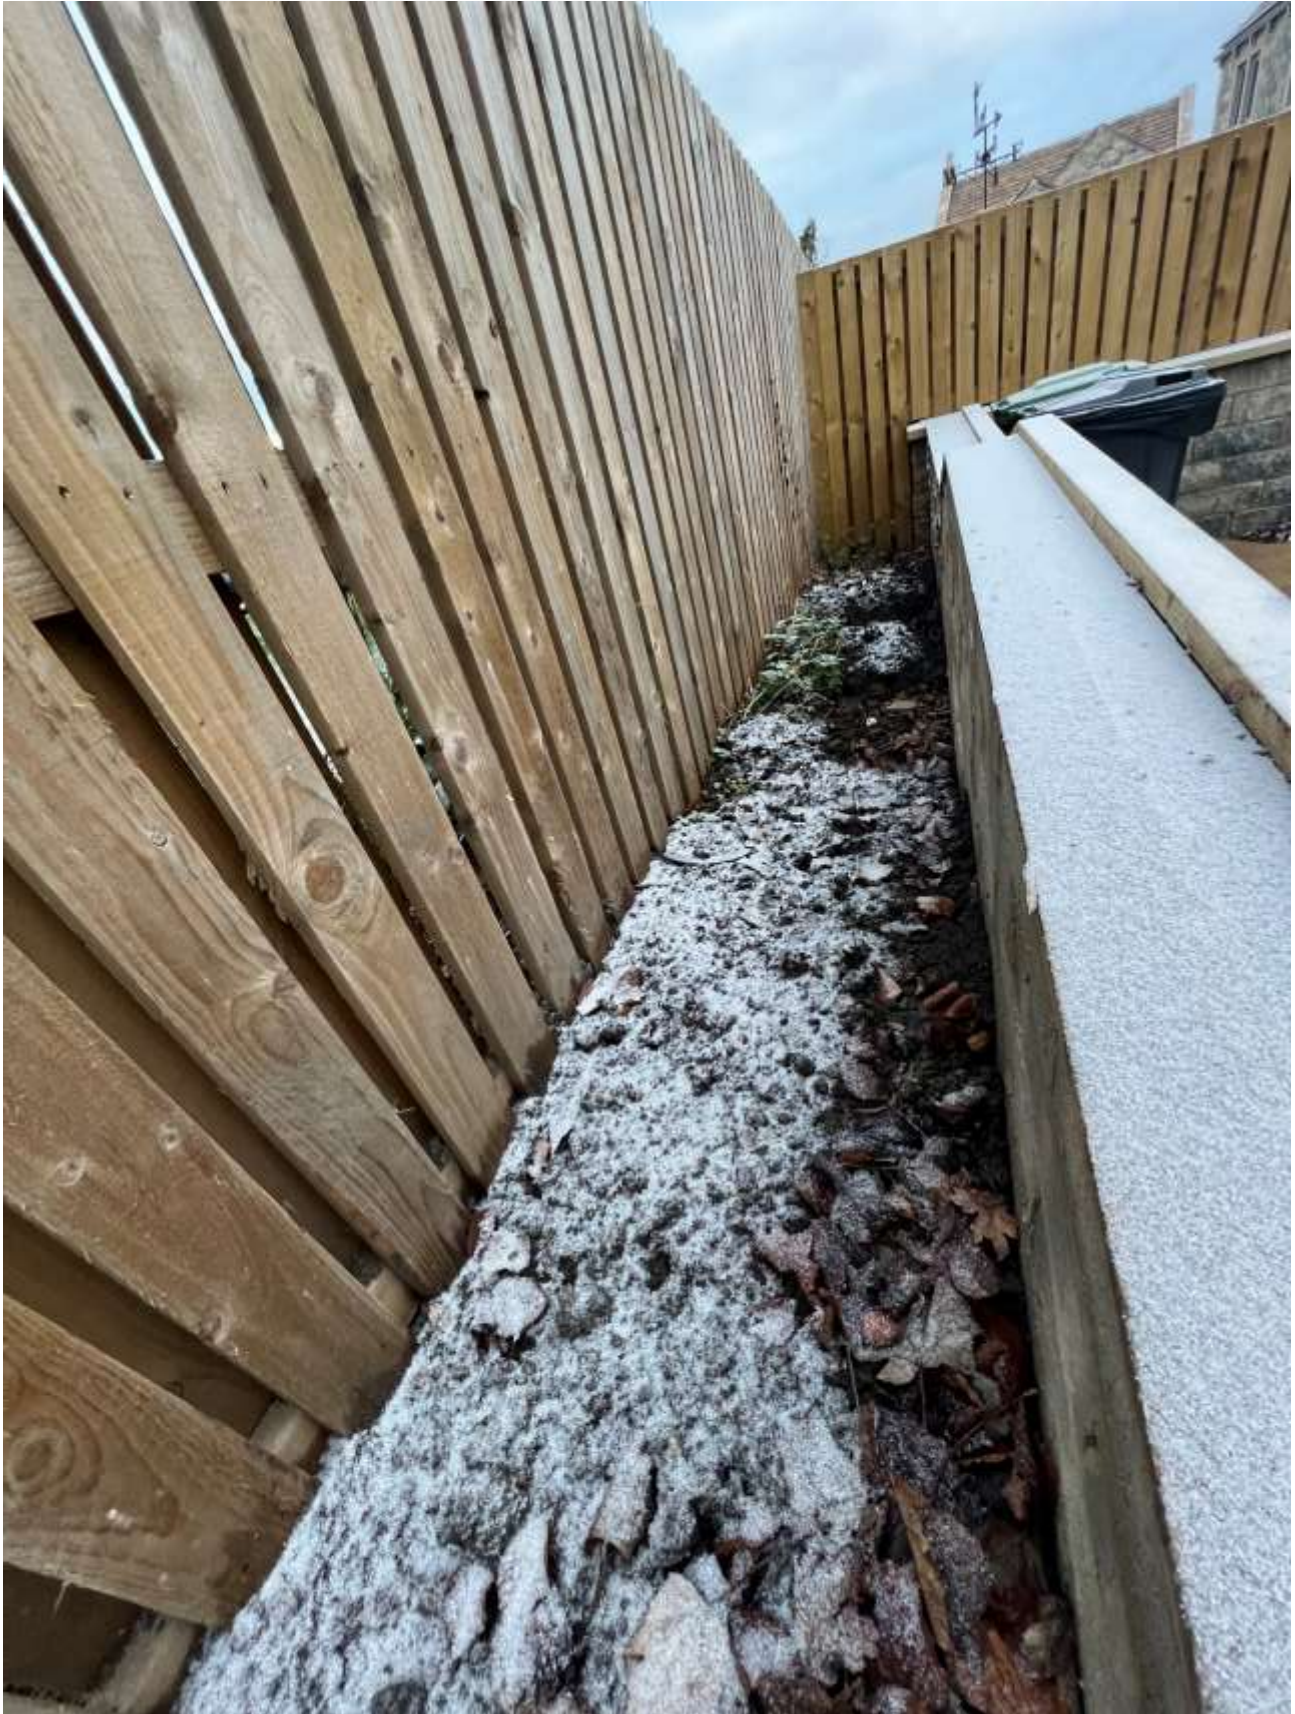
The retaining wall built at the end of the driveway appears to be unnecessary, as it is not retaining any earth and in the opinion of the homeowners, will act as a 'rubbish trap'. There is no provided access to maintain this area safely. The retaining wall was not detailed in any plan provided and has actually impeded the space that was designated for bin stores, **Figure 5.8**.

**Figure 5.8 Unnecessary retaining wall wasting space**

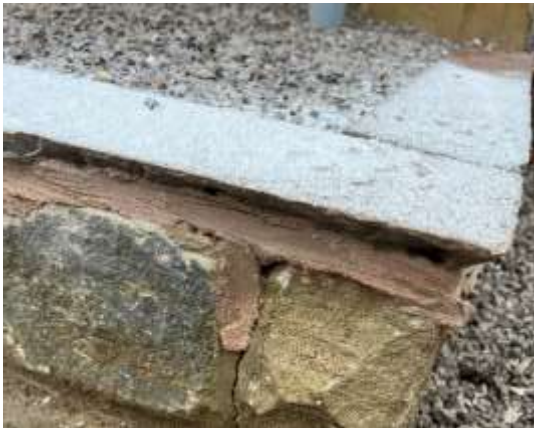
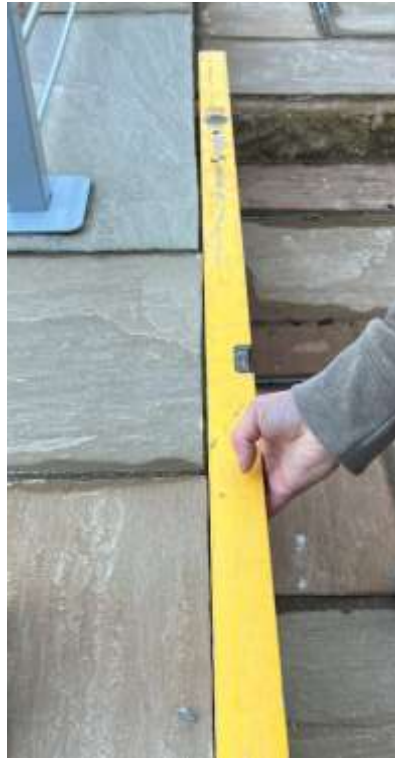
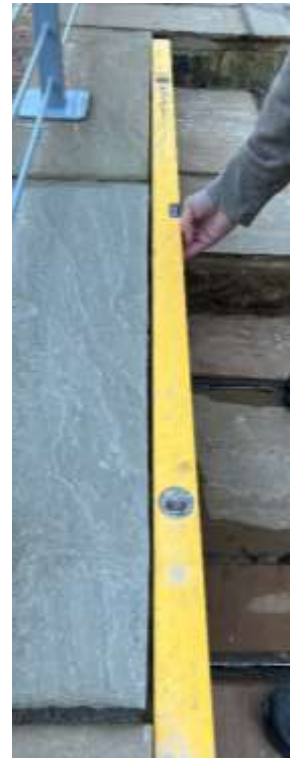
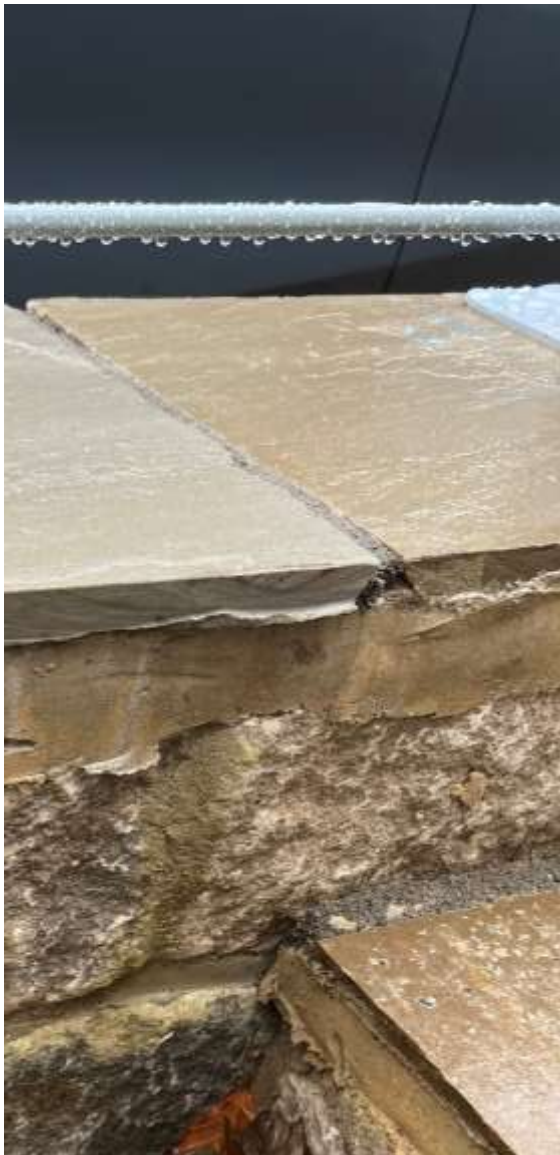
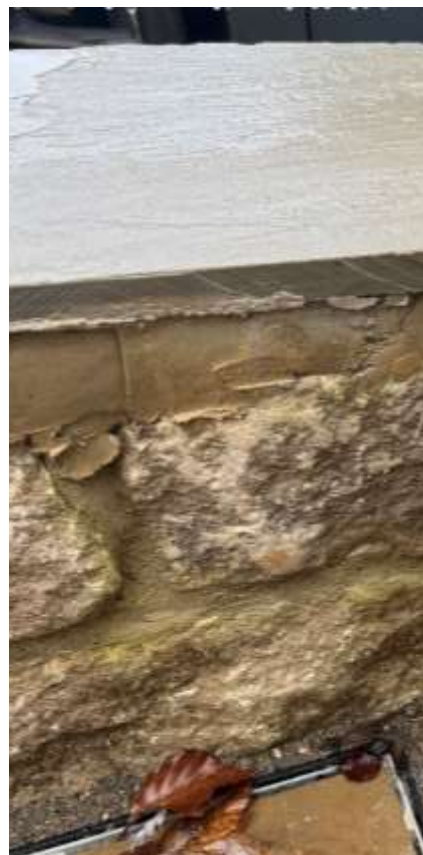
Poor materials choice and poor workmanship in the approach to the dwelling detracts from the quality of the external aesthetic appearance of the dwelling, **Figure 5.9**.

**Figure 5.9 Incorrect material selection and poor workmanship**

Incorrect materials been used on the approach to the dwelling has massively impacted the aesthetic quality of the build. Cut down paving slabs acting as coping stones, that aren't cut straight and left with jagged edges on them, laid onto a wall out of line with each other, not level with each other and with no allowance for a drip is another nod to the amateur attempt at finishing a £364,950 property.
