***INSPECTION REPORT***

REPORT COMPRISING OBSERVATIONS AND FINDINGS IN RELATION TO EXTERNAL ASPECTS OF:

**PLOT 25 – [REDACTED]**

Date: 04/01/2023

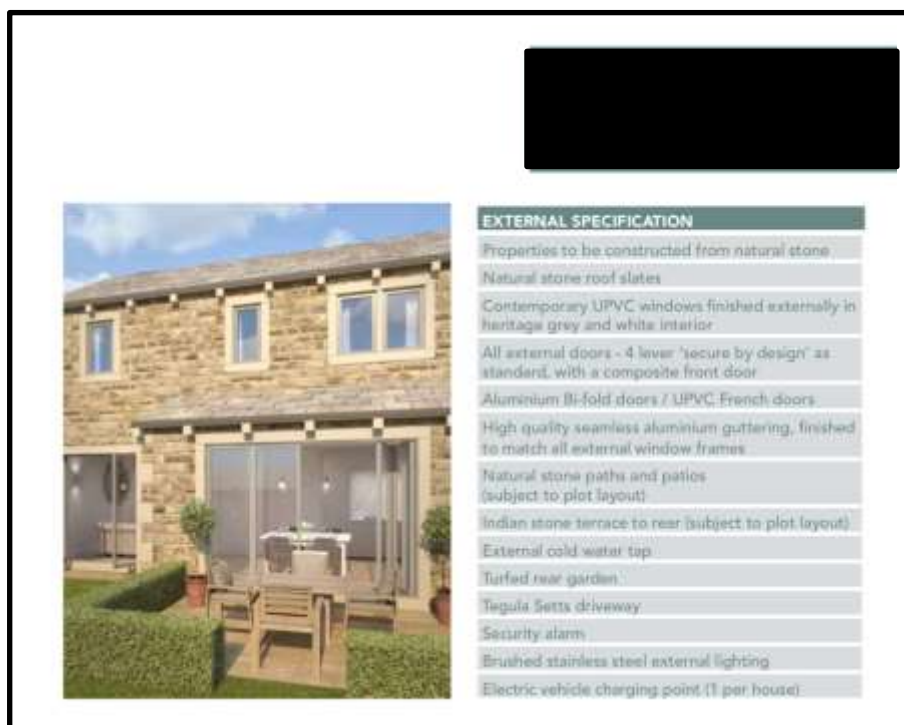
**Figure 1.2 Excerpt from provided sales brochure showing specification**

As part of the sales brochure, a specification was provided, **Figure 1.2**, which states that as part of the specification a rear turfed garden would be provided. Plot 25 has not been provided with a turfed area to the rear, **Figure 1.3**.

Notification of these changes to plan or specification **were not** communicated to the homebuyers, and in their prejudice these changes have altered the quality and value of the property.

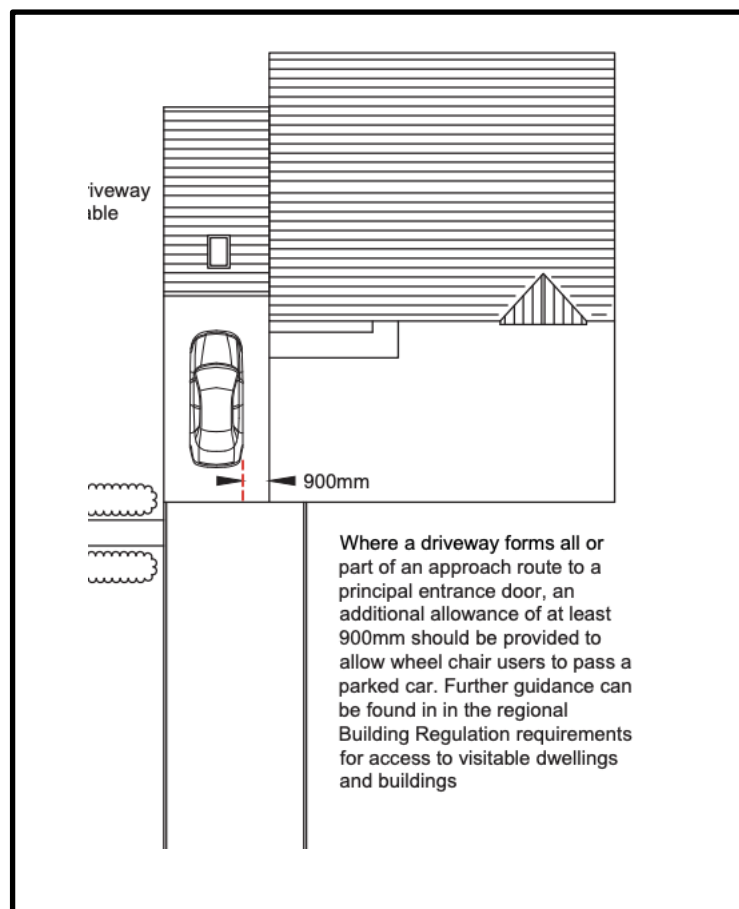
**Figure 2.1: Excerpts from *Approved Document M* (Top) and *Premier Guarantee – Technical Manual v14* (Bottom)**

The building regulation document, *Access to and use of buildings – Approved Document M*, states that if a driveway forms part of the access route into the dwelling, an additional provision of a 900mm walkway, alongside the standard parking space, must be made. *Approved Document M* defines a standard parking space to be 2.4m wide by 4.8m long. This would mean that a total **minimum** width of 3.3m is required – if the driveway forms part of the access route. Excerpts from *Approved Document M & Premier Guarantee – Technical Manual v14* showing this information are shown in **Figure 2.1**.

The drawing provided to the homeowners during the purchase of the property, **Figure 2.2**, depicts the access route coming from the road, mitigating the need for the additional 900mm walkway. In reality, the access has been constructed from the far side of the driveway, **Figure 2.3**, therefore the driveway forms part of the access route. Had the access been constructed as shown in drawing provided to the homeowners, this issue would not have arisen. It is not clear why the deviation from the drawing provided to the homeowners has occurred.
